Site AC2C: Port Royal

Date Assessed: 30/11/04

Road Crossing: Culvert
(wooden/square), 1m

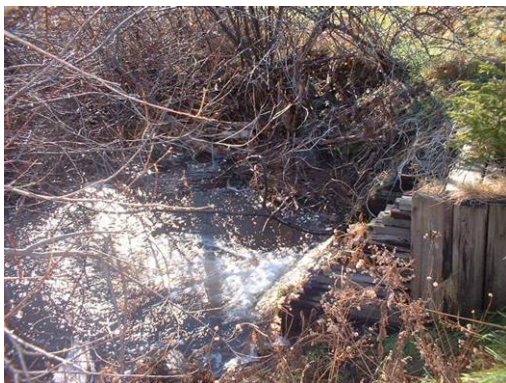
Creek: 3m wide, scour pool, bank slumping, still water and turbulent flow.

Figure 1. Downstream view of crossing

Comments: This crossing is not very influenced by the tide due to the rise in elevation however it is a slightly restricting water flow evident by the scour pooling, erosion and difference in stream widths and therefore opening could be enlarged when repairs are made.

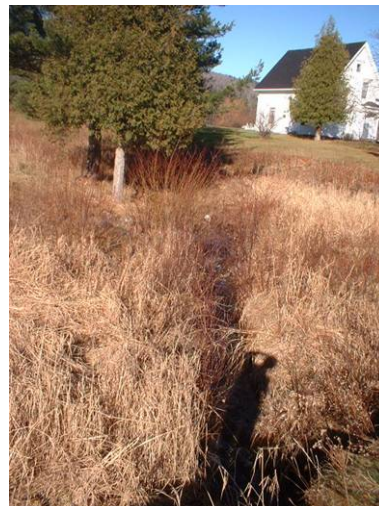
Creek: 1m wide with turbulent flow.

Figure 2. Upstream of crossing
