**Site AC4C:** Dixon Brook

**Date Assessed:** 30/11/04

**Crossing Status:** Partial restriction

**Road Crossing:** Culvert  
(wooden/double square), 3m

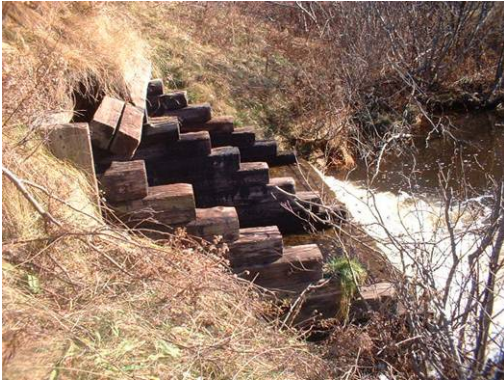
**Comments:** Due to the rise in elevation tidal flow may not influence this site considerably, however there is a restriction to water flow caused by this crossing as evident from the scour pool formed at the opening as well as the considerable erosion of the stream banks. Culvert opening could be enlarged to improve stream conditions, although salt marsh habitat will not be increased.

Figure 1. Downstream view of crossing.

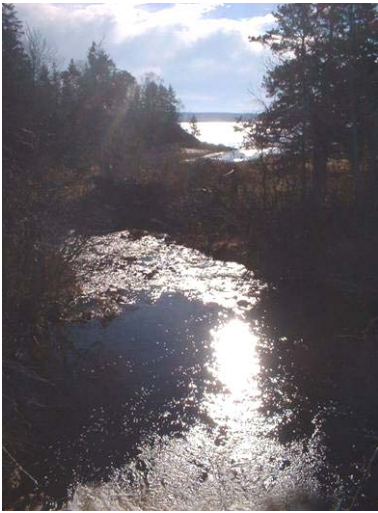
**Creek:** 8m wide, scour pool, slack water and bank slumping, trees are falling into creek. Culvert is not flush with creek bottom

Figure 2. Downstream of culvert

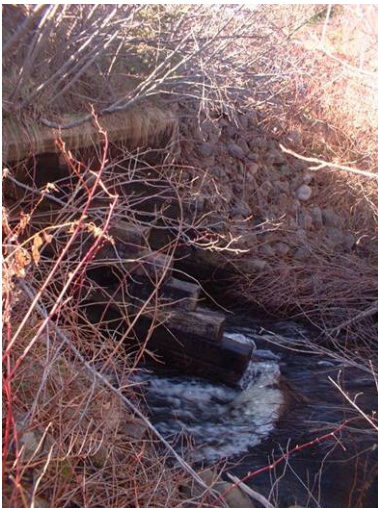
**Creek:** 3m wide, with bank slumping and turbulent flow.

Figure 3. Upstream view of culvert.
