Site AC6C: Granville

Date Assessed: 30/11/04

Crossing Status: Partial restriction

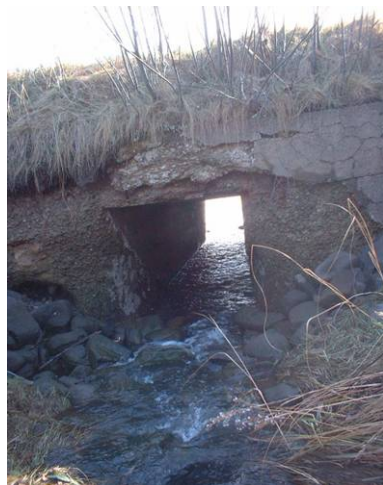
Crossing Condition: In some disrepair,  
eroding in places

Creek: 1m wide, small scour pool, some bank slumping

Figure 1. Upstream view of crossing

Comments: While there is not a huge restriction to tidal flow, this crossing is in need of repair, at which time enlargement of the opening should be considered.

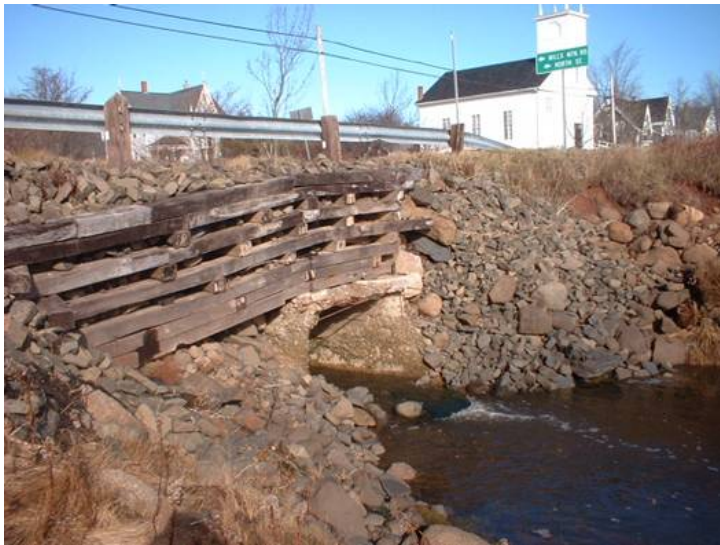
Land: Small salt marsh bordered by trees and residences.

Figure 2. Upstream of crossing

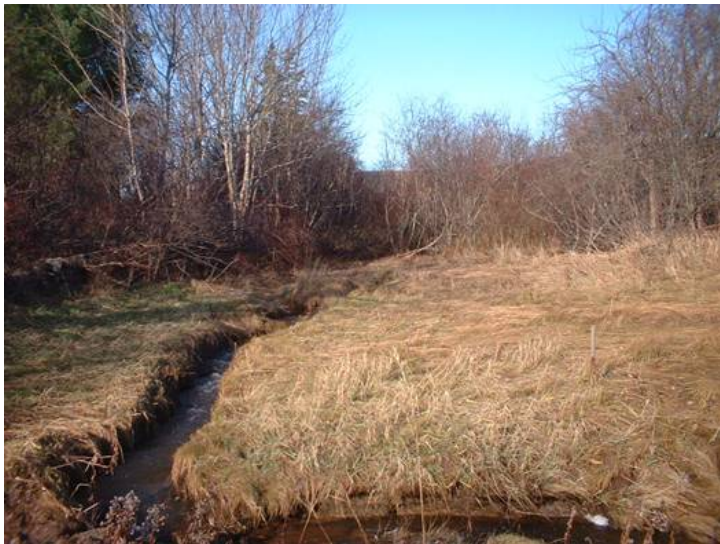
Creek: 5m wide at crossing, some bank slumping. Opens into the Annapolis Basin

Figure 3. Downstream view of crossing

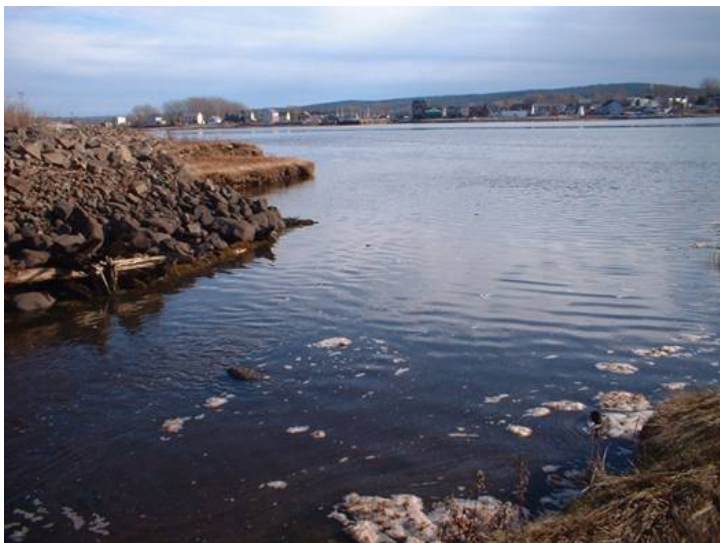
Land: Beach

Figure 4. Downstream of crossing
