Site AC8B: Allains River (Rte1)

Date Assessed: 26/08/04

Road Crossing: Hwy Bridge (concrete/steel) and Rail bridge, 100m each

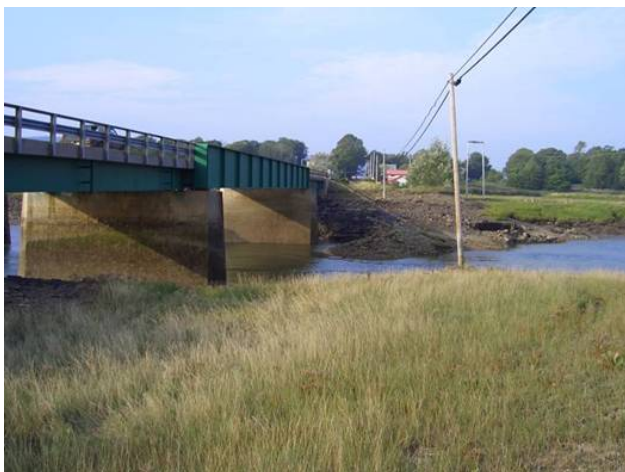
Comments: While this crossing does not pose as a significant restriction to tidal flow the remnants of the old bridge structure and the rock piles at the base of the bridge, both up and downstream are causing disruption to tidal flow. On the downstream side there is a large scour pool between the railway and highway bridge. This river is also largely dyked and assessments of the usage of farmland could be made to determine if breaching of dykes is possible in the future to restore salt marsh habitat.

Figure 1. Upstream view of bridge showing large rock pile near base of bridge.

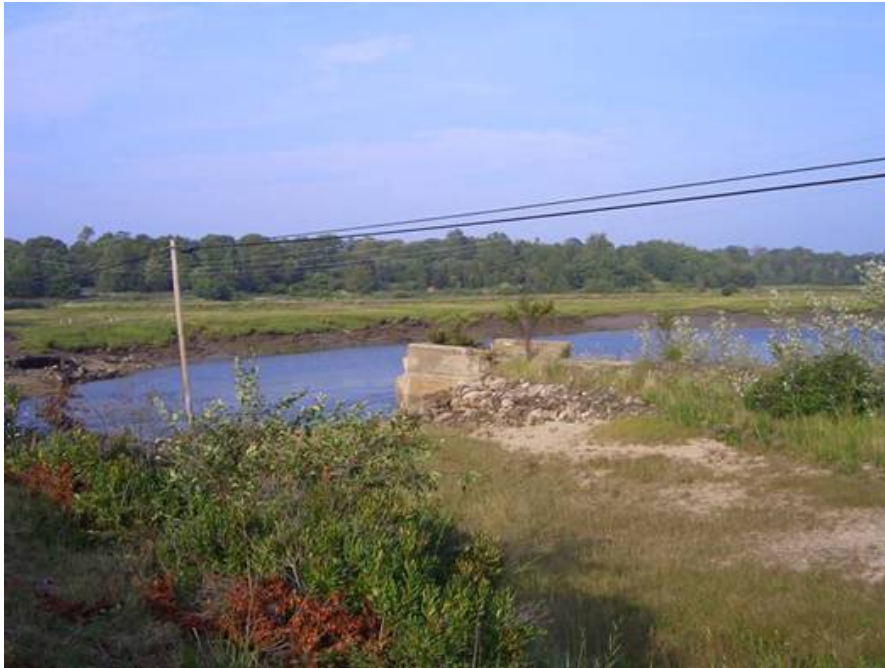
Figure 2. Upstream remnants of old Crossing.

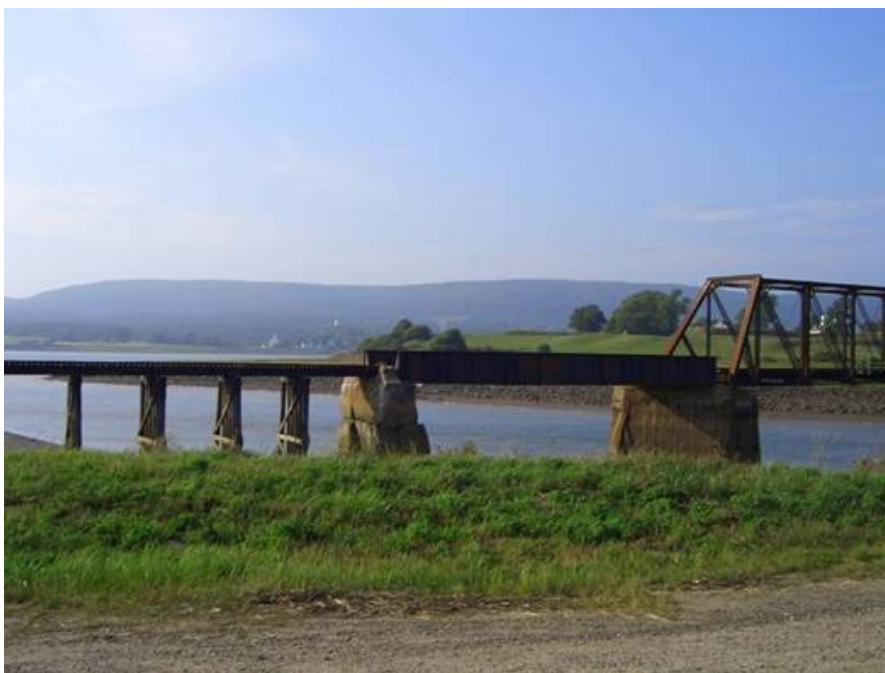
Figure 3. View of downstream and rail bridge
