Site AC9C: Moose River (East)

Date Assessed: 26/08/04

Crossing Status: Partial restriction

Road Crossing: Culvert (concrete/open bottom), 9.5m

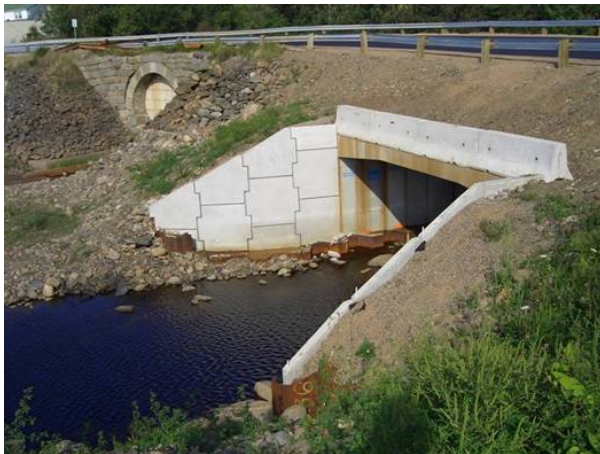
Comments: This crossing was recently installed. There is an old round concrete culvert to the north that is now sealed off. Water is still directed to this old crossing and creating a scour pool. The new crossing is larger than the old one and tidal flow is not as restricted.

Figure 1. Downstream view of crossing, old sealed crossing to the left of new culvert

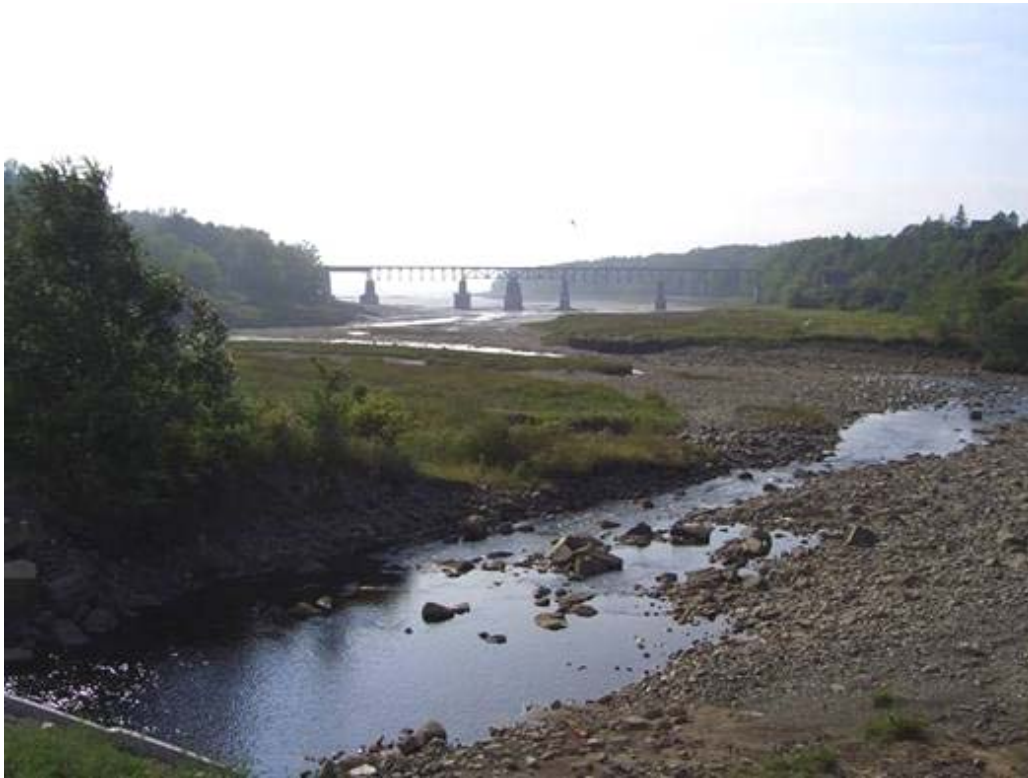
Creek: 12m wide smooth flow with scour pool and some bank slumping

Figure 2.
Downstream of
crossing
