Site CBNS17C: Shad Brook

Date Assessed: 11/07/02

Crossing Status: Partial Restriction

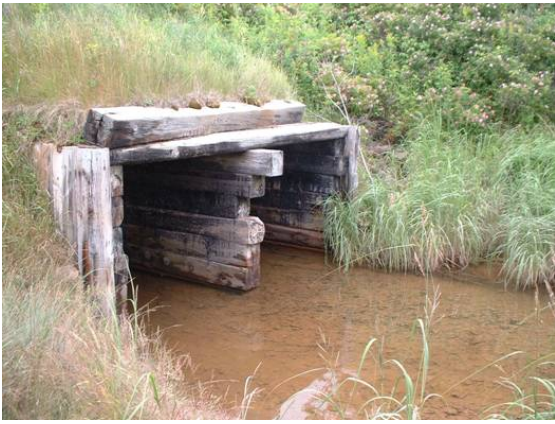
Figure 1.

Road Crossing: Culvert (2 openings)
wooden box, 1.73m opening

Crossing Condition: In need of repairs,
division between openings is caving to one
side.

- Difference in water level
- Difference in vegetation
- Scour pool
- Bank slumping
- Divergent channel
- Slack water

Comments: Culvert should be replaced with a larger opening to restore a more natural tidal flow.
