**Site CBNS18B:** North River, Five Islands

**Date Assessed:** 20/06/02

**Road Crossing:** Bridge, concrete, 33.5m opening

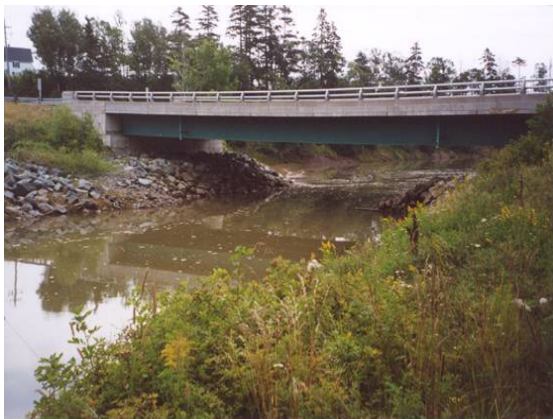
**Figure 1.**

**Crossing Condition:** Intact. There is an old wooden structure in the bank underneath bridge.

**Comments:** While this crossing is not posing as a large restriction to tidal flow, the old bridge structure still in place under the new bridge is slightly pinching the river channel. There is also a lot of rock debris around base of the bridge which could be dredged. Size of the opening should be maintained and remove old bridge structure underneath it.
