Site CBNS3B: Folly River

Date Assessed: 19/06/02

Road Crossing: Bridge, concrete, 35m wide

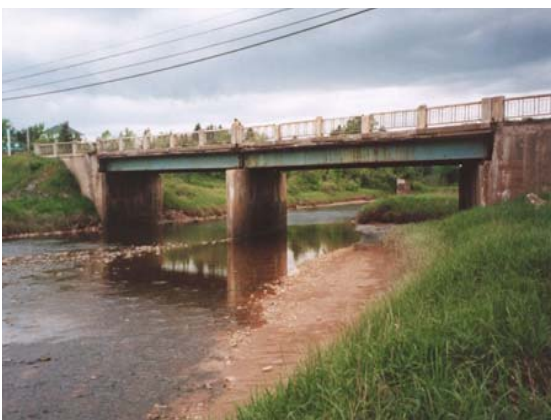
Figure 1.

Crossing Condition: In need of some repairs. Sidewalk sections of bridge are crumbling and the railings are breaking and falling down.

Comments: Repair bridge and maintaining the size of the opening.

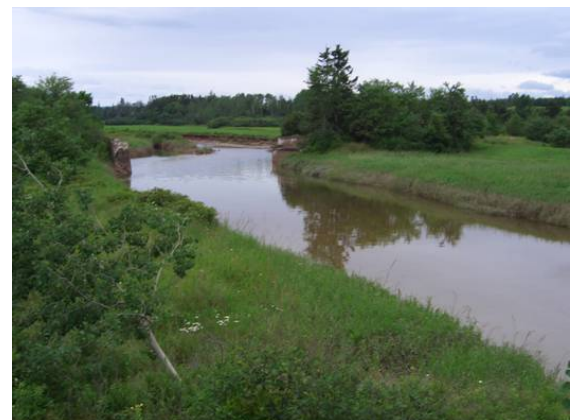
Figure 2.

Creek: 30m wide, smooth, straight flow, with little bank slumping. Bridge supports are causing channel to move mostly through half of the opening.

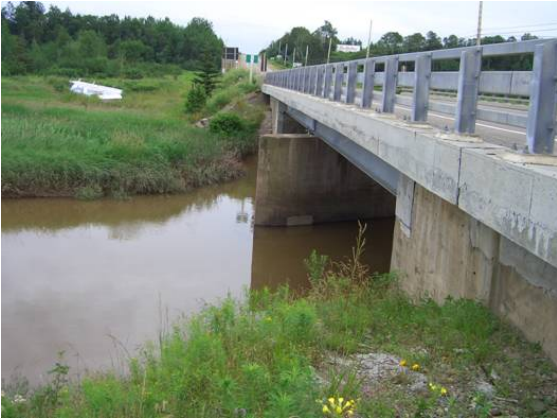
Figure 3.

Creek: 35m wide, smooth, straight flow with little bank slumping.
