**Site CBSS12C:** Cobequid Trail**Date Assessed:** 07/02/02

**GPS Coordinates:** N 45° 20' 50.4''  
W 63° 24' 5.6''

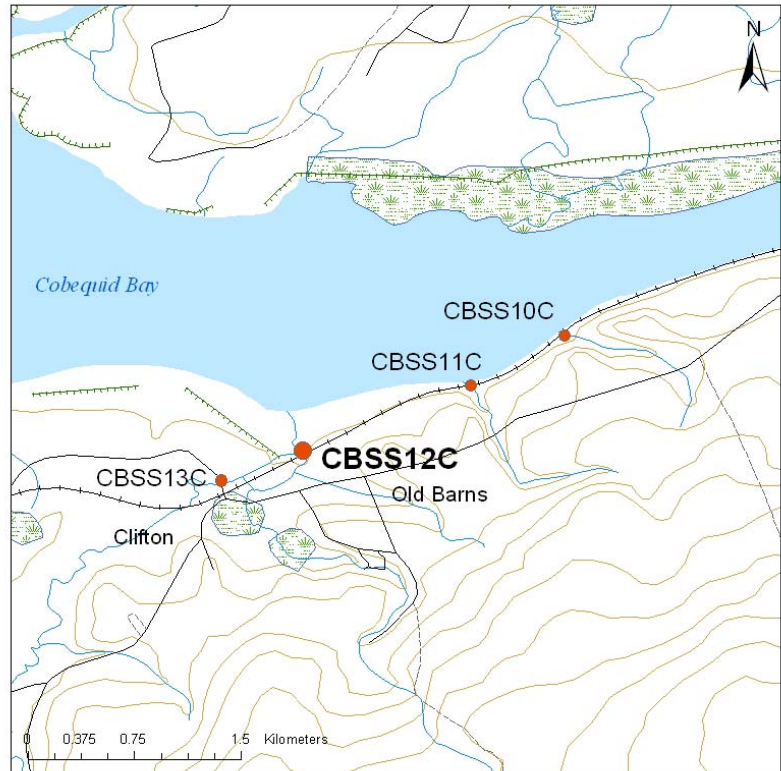
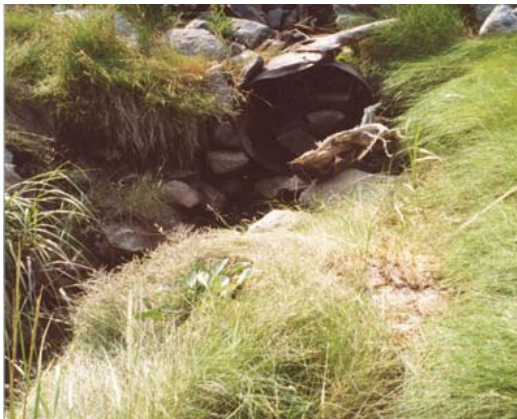
**Figure 1.**

**Crossing Condition:** In poor condition, rusted out and pieces are missing.

**Comments:** Rusting culvert is beginning to collapse and should be replaced with larger opening.
