**Site CBSS7C:** Cobequid Trail

**Date Assessed:** 01/08/03

**Road Crossing:** Culvert, cement, 2.4m wide

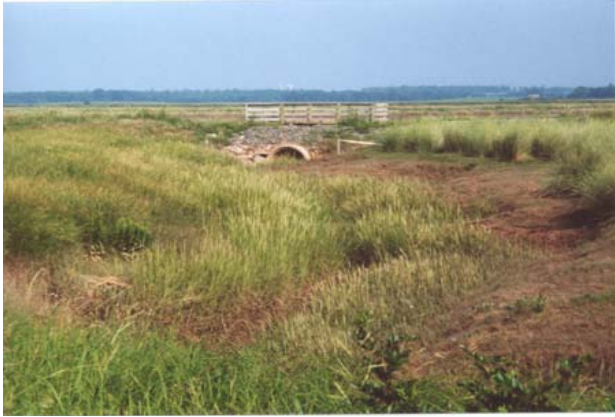
**Figure 1.**

**Crossing Condition:** Structure is intact. Culvert located quite high up along the bank which could interfere with regular water passage. Rock banking around culvert on upstream side to prevent erosion.

**Restriction Indicators:**  
Difference in stream width  
Bank slumping  
Turbulent flow

**Comments:** Replace culvert such that it is located lower on the bank to allow for more regular water flow, which currently only passes through during and close to high tide.
