**Site ST5C:** Little Hurd Brook

**Date Assessed:** 10/07/02

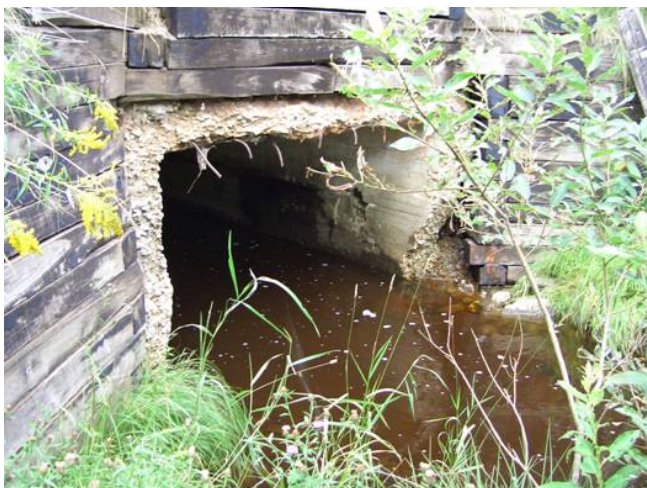
Figure 1

**Crossing Condition:** Intact but  
cement is eroding. There are wooden  
planks placed around culvert to help  
prevent erosion.

**Comments:** This crossing does not appear to be very tidal, or may be at the tidal edge of the system.  
Maintain size of opening.
