Site CCCB 10C: Maccan Loop

Date Assessed: July 8, Aug. 27-8,
Nov. 18, 2003

Road Crossing: 1m/1m wooden
culvert (potential aboiteaux).

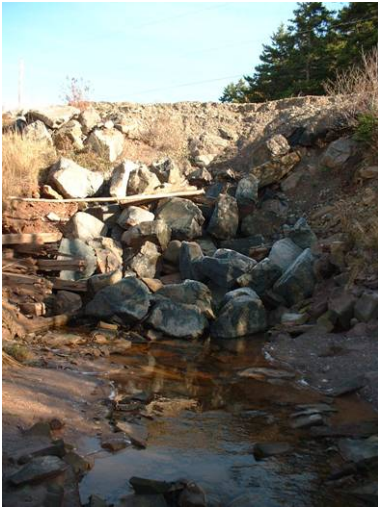
Crossing Condition: Collapsed and
buried on downstream side, rotting and
starting to collapse on the upstream
side. Shoulder of road above
downstream end appears to be
collapsing/slumping.

Figure 1. Downstream end of crossing completely buried by rock and other materials. Unclear as to whether a tidal gate is present or not. Damage to shoulder of road surface evident in picture.

Comments: Replace culvert with a larger opening. At a minimum excavate downstream end of culvert and repair road.

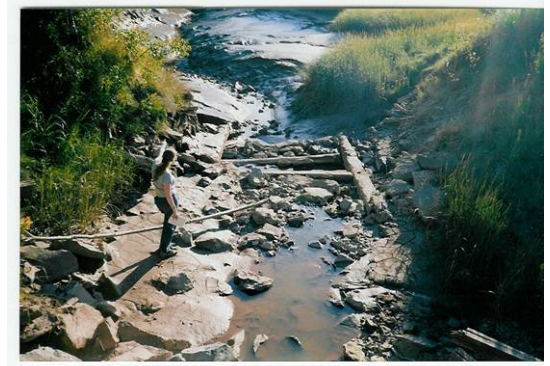
Creek: Creek is 5m wide with a turbulent flow. Banks are slumping, and there are remnants of an old aboiteau causing a 0.5m drop.

Figure 2. Downstream of the crossing. Remnants of an old structure, possibly an aboiteau, are visible.

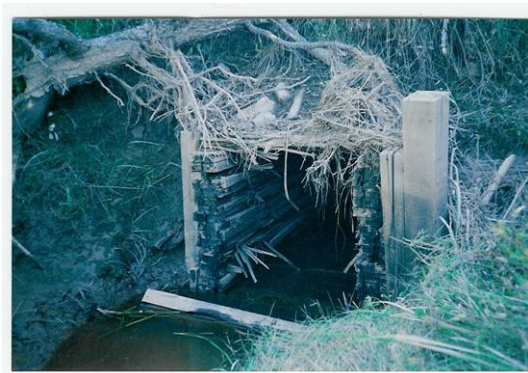
Figure 3. The upstream side of the culvert. Some debris is visible as well as damage to culvert.
