Site CCCB 11B: Haycock Brook (River Hebert) Date Assessed: July 8, Aug. 27-8, Nov. 18, 2003

Road Crossing: 18m long, one lane steel bridge with wood supports for banks.

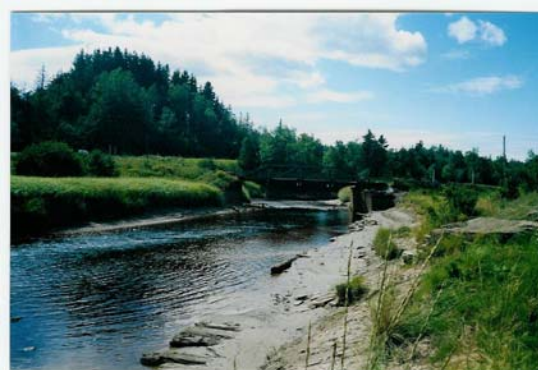
Figure 1. Downstream of non restrictive bridge.

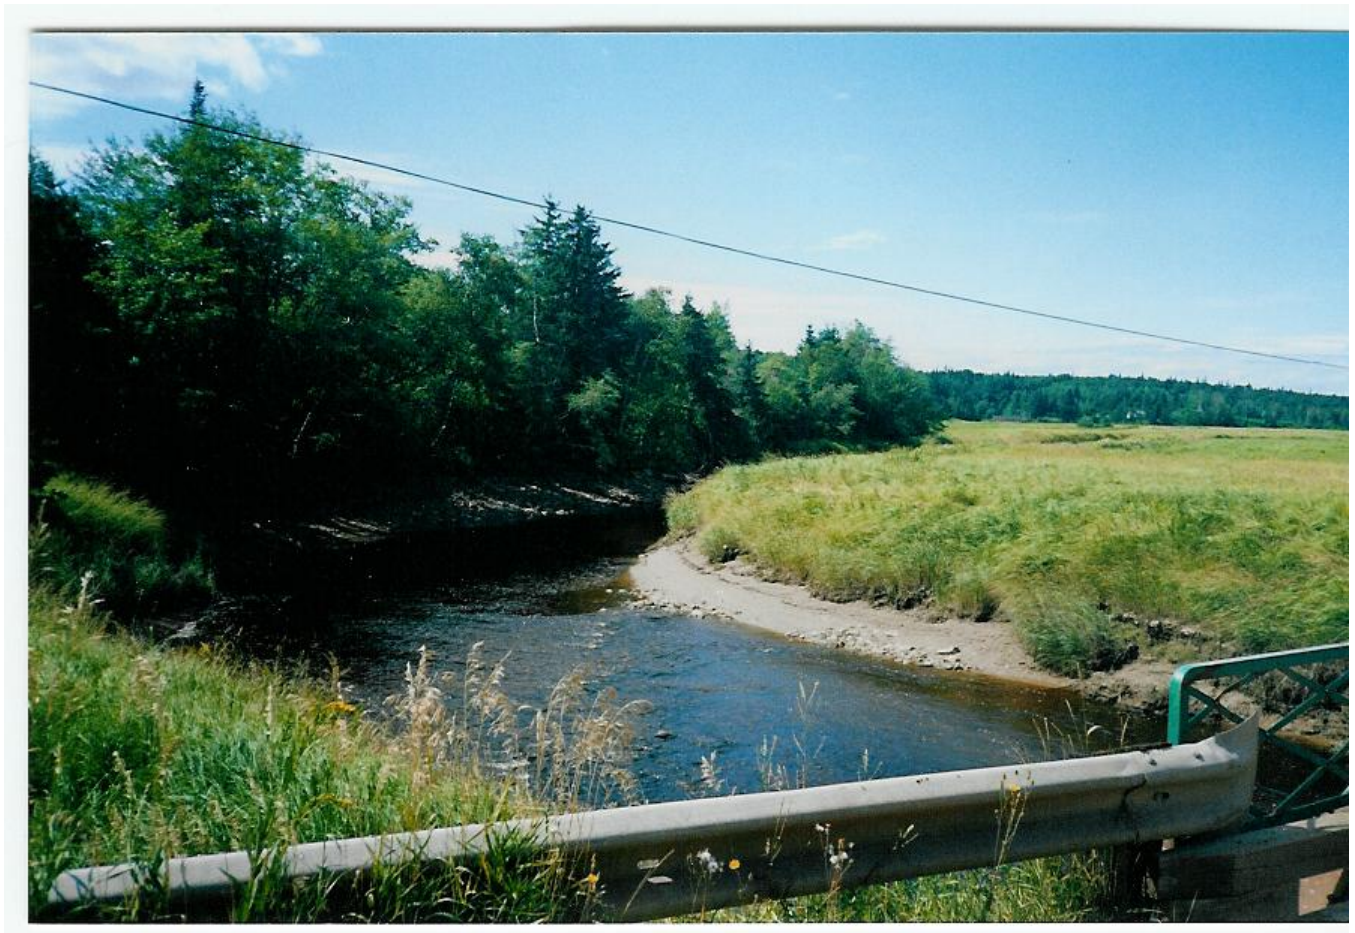
Figure 2. Downstream view of creek from the road.
