Site CCCB 13C: Christie Brook (River Hebert) **Date Assessed:** July 8, Aug. 27-8,
Nov. 18, 2003

Crossing Status: Partial restriction.

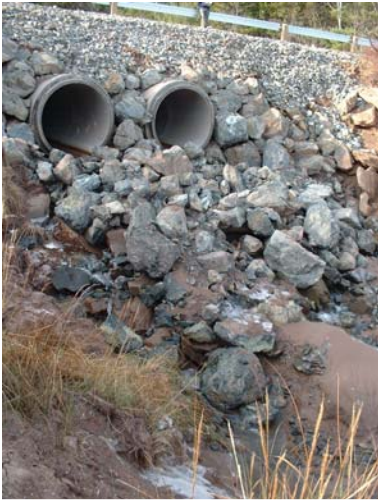
Road Crossing: 2 large concrete culvert, 1.5m diameter each. Culverts are placed approximately 3m above creek bed on the downstream side representing a significant obstruction to tidal flow and fish passage. When the crossing was first visited in August, 2003, a restrictive wooden box culvert was assessed and determined to be in considerable disrepair. Upon revisiting in November it was discovered the crossing had been replaced by two round concrete culverts that did not improve hydraulic condition or fish passage. Riprap is already collapsing into and clogging new culverts.

Hanging culvert

Figure 1. The downstream view of the new culverts.

Comments: Enlarge opening and eliminate hanging culvert, address fish passage.

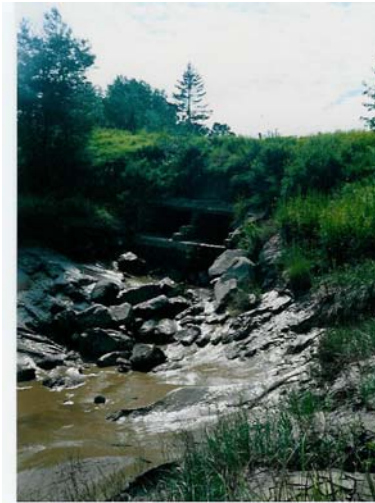
Figure 2. The downstream view of the old culverts

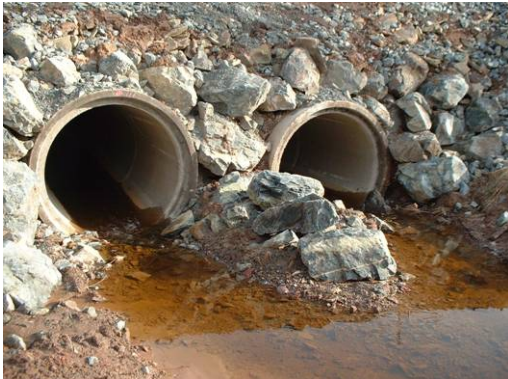
Creek: Creek is split into two channels, each directed towards a culvert. Gravel is already beginning to accumulate inside culverts.

Figure 3. Upstream of the new culverts.

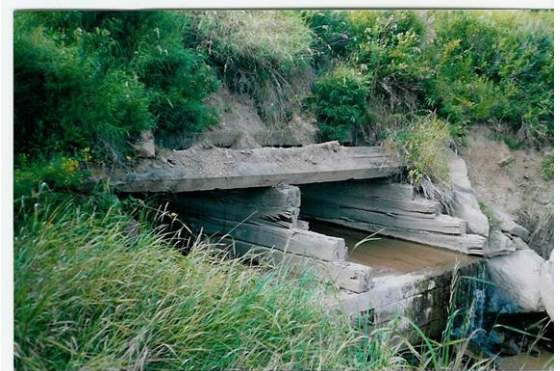
Figure 4. Close up of the old, double chambered, wooden culvert.

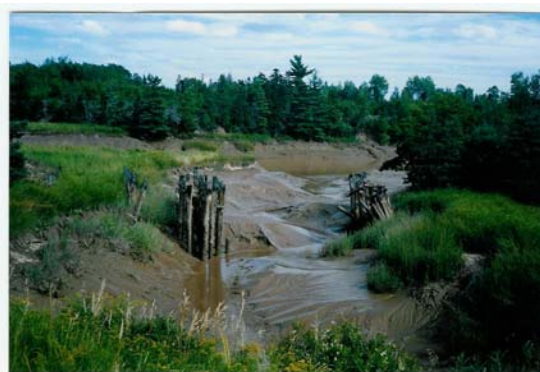
Creek: Creek is approximately 10m wide with remnants of old bridge structure still visible downstream.

Figure 5. Downstream of the crossing. Remnants of the old bridge are visible.
