Site CCCB 15B: River Hebert (Hwy 242 Bridge)      Date Assessed: July 8, Aug. 27-8, Nov. 18, 2003

Road Crossing: 70m concrete bridge.

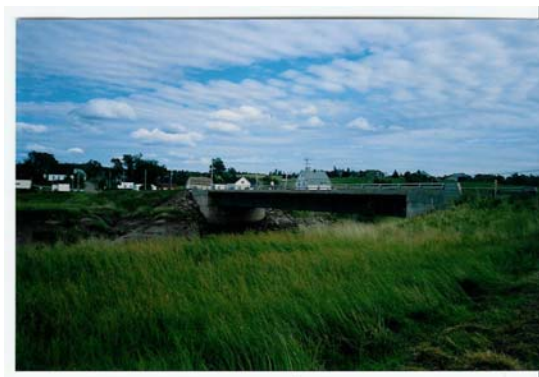
Crossing Condition: Structure is intact.

Figure 1. Bridge seen from the downstream side.

Comments: If replacement is ever needed, maintain the size of the bridge. There may be opportunities along this river to remove dykes and restore river floodplain and marsh habitat.

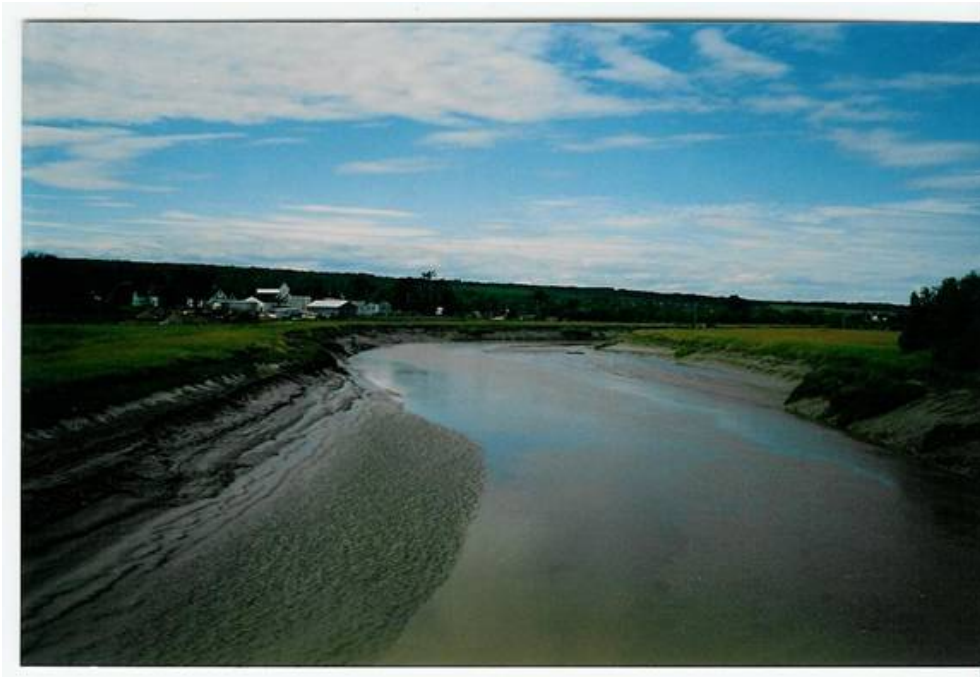
River: Smooth flow, 50m wide.

Figure 2. The river downstream from standing on the bridge.

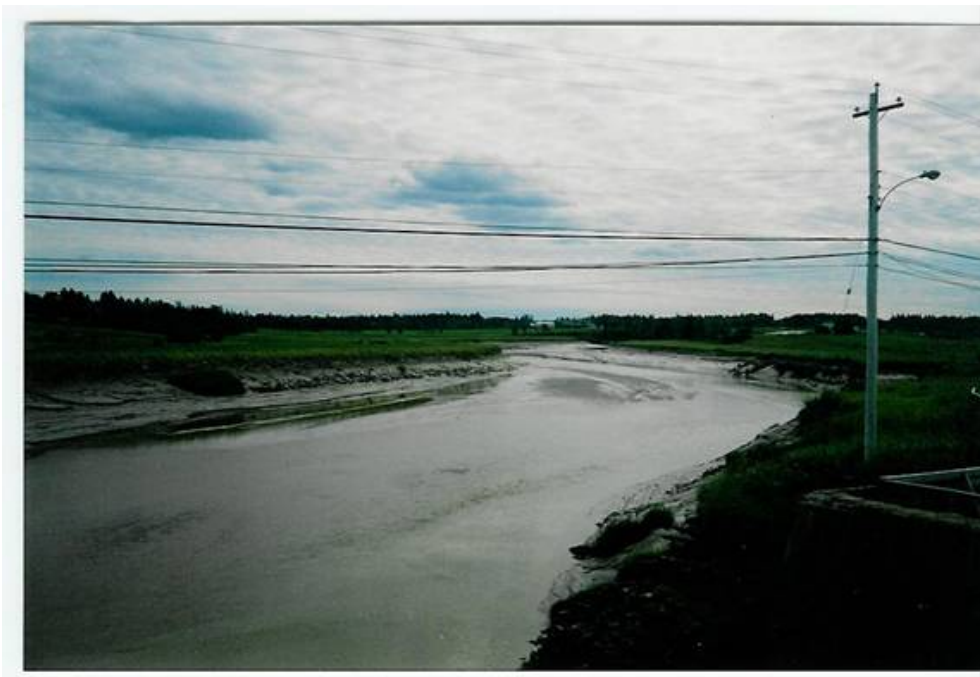
River: Smooth flow, 50m wide.

Figure 3. The river upstream from standing on the bridge.
