**Site CCCB 16C:** John Curry Brook (River Hebert) **Date Assessed:** July 8, Aug. 27-8, Nov. 18, 2003

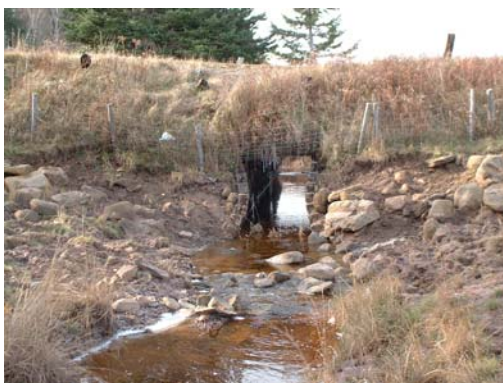
**Crossing Condition:** It is starting to cave in on one side.

**Creek:** 2.5m wide has no protection from the animals that graze the marsh surface/field. The banks and creek bed are being destroyed by farm animals.

Figure 1. Downstream view of the culvert caving in on the sides. The banks of the creek are being trampled and eroded by animals.

**Comments:** Replace collapsing culvert with larger crossing. Keep animals out of creek bed. Assess downstream obstruction (likely dyke and aboiteaux) and land use. This was formerly large marsh area both upstream and downstream, however appears to be actively farmed downstream, while upstream is not being used.

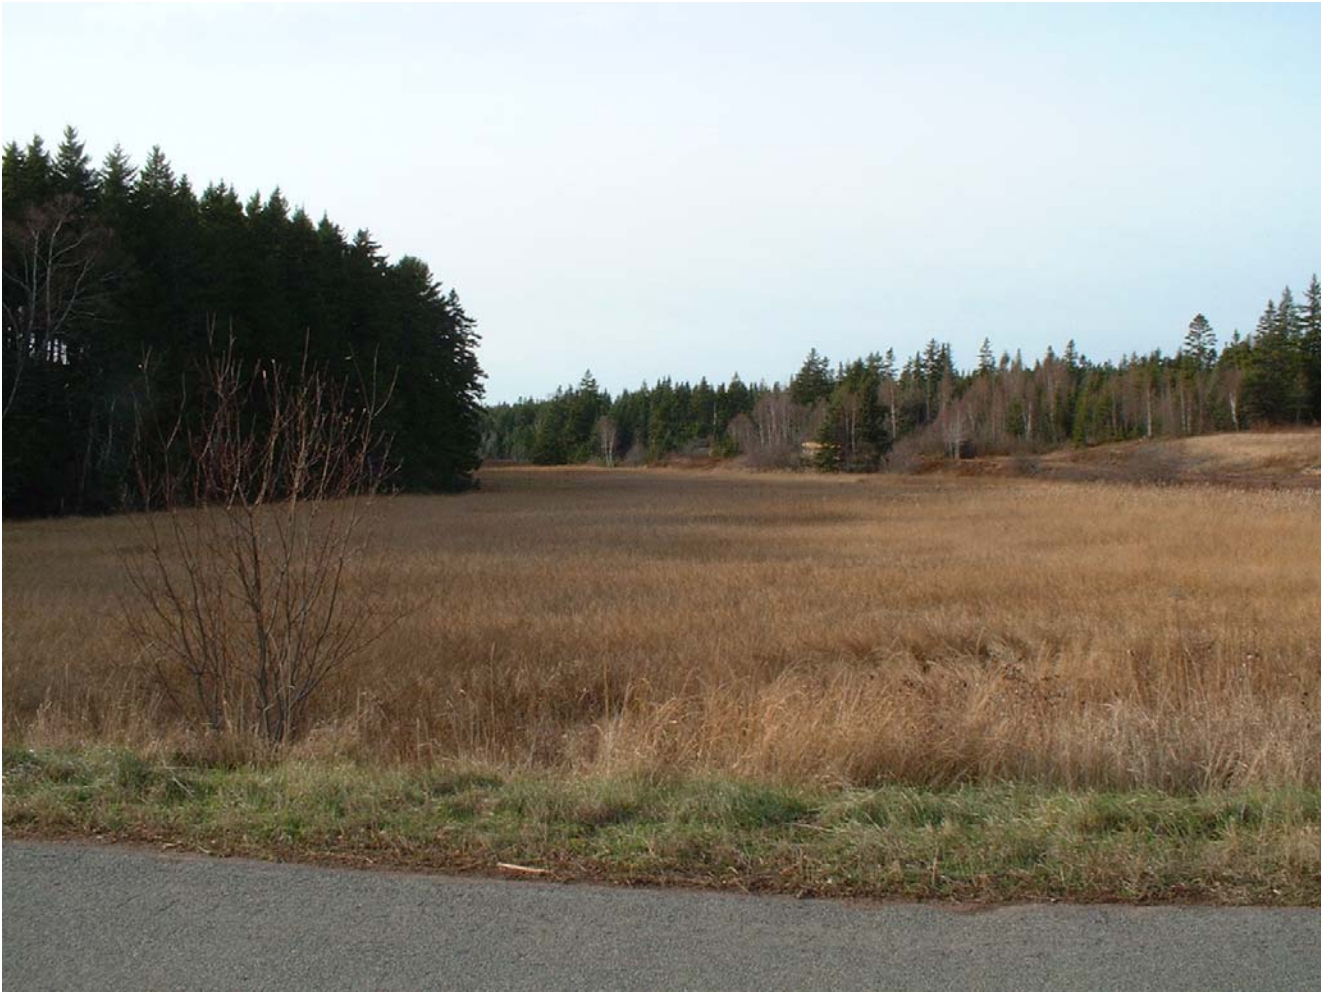
**Land:** Agricultural land not actively used.

Figure 2. Upstream land with the creek to the left of the picture by the forest. Photo taken from the road.
