Site CCCB 18A: Mill Creek

Date Assessed: July 8, Aug. 27-8,
Nov. 18, 2003

Crossing Status: Complete restriction.

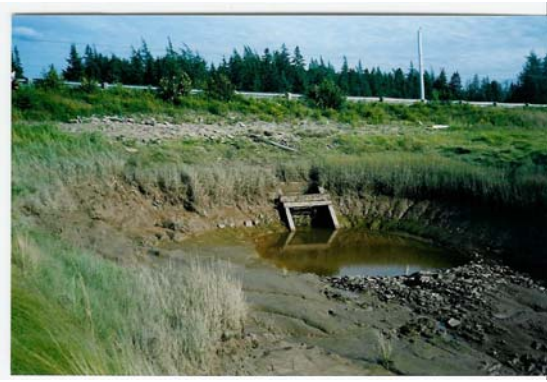
Creek: 19m wide scour pool in front of culvert and bank slumping.

Figure 1. The downstream view of the culvert showing the bank erosion from pooling and perspective on how small the culvert is with respect to the pool.

Comments: Initially remove tidal gate and ultimately replace crossing with a much larger opening.

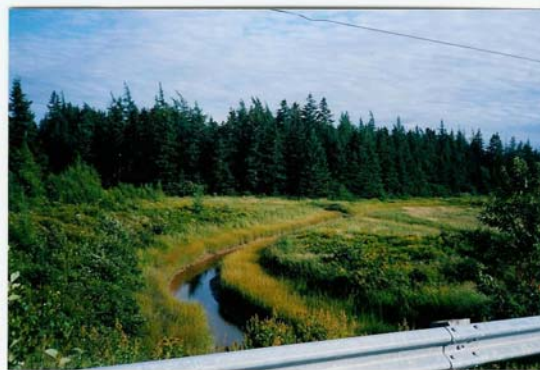
Creek: Channel is approximately 3m wide with some scouring and still water.

Figure 2. The upstream creek from the road which is noticeably smaller than downstream. Invasion of fresh water vegetation over the marsh surface.

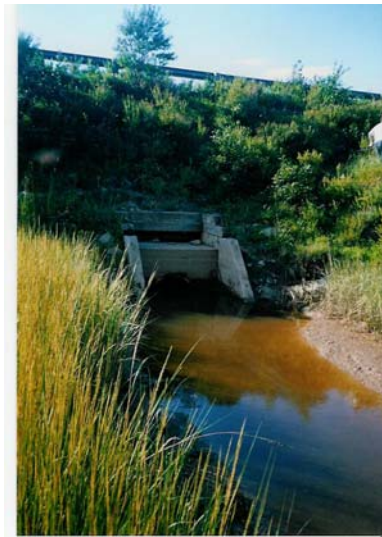
Figure 3. Upstream side of the culvert. There is a slight pooling in front of it. The old wooden box culvert is easily visible, with just the top of the round concrete culvert visible.

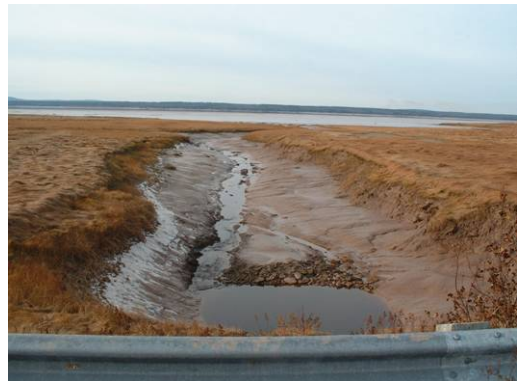
Figure 4. Downstream creek from the road. The pooling is evident in this photo.
