Site CCCB 19B: Little River (Near Lower Cove) **Date Assessed:** July 8, Aug. 27-8, Nov. 18, 2003

Road Crossing: A 21m long wooden bridge that is beginning to show age and wear.

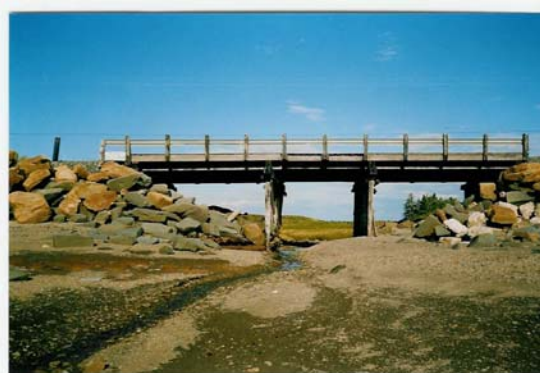
Figure 1. Downstream of the bridge on the beach.

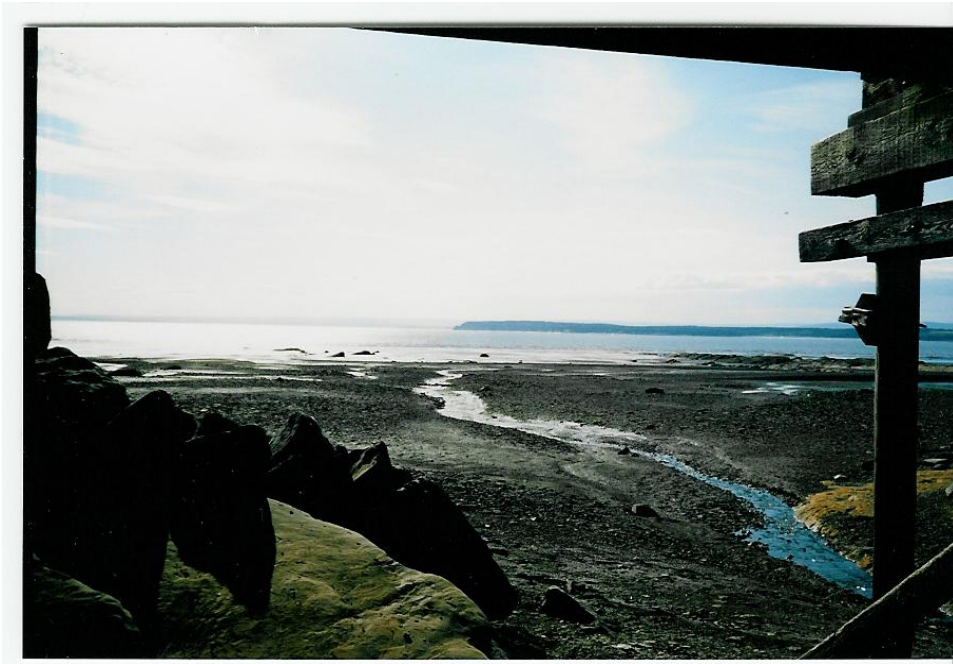
Crossing Condition: Road is in disrepair with holes at the joints of the road and the bridge, and the supports under the bridge may soon need to be repaired or replaced.

Figure 2.
Downstream
from under the
bridge.

Comments: Repair or replace bridge, maintaining opening width. Remove rock material under bridge in order to increase opening and improve flow.

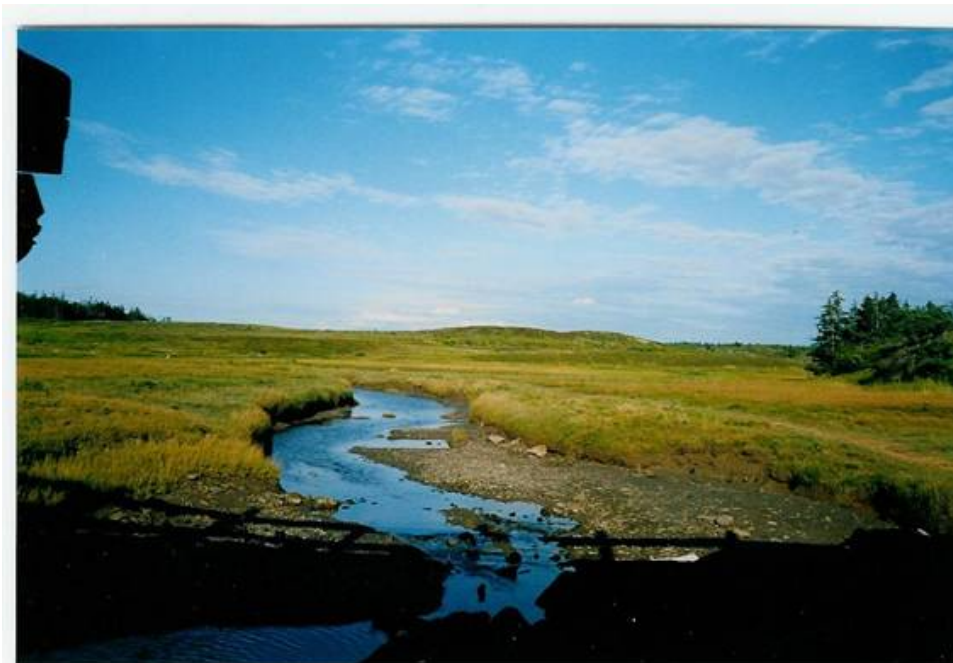
Figure 3. Upstream
creek and salt marsh.
The hill in the
background is where
the blueberry fields
begin.
