Site CCCB 1B: Missaguash River

Date Assessed: 01/08/03

Road Crossing: Two adjacent 40m long concrete bridges (divided highway)

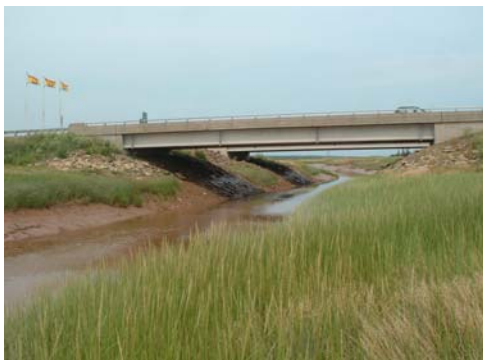
Crossing Condition: Structure is intact.

Figure 1. The bridge from a downstream bank.

Comments: When repair or replacement is necessary, maintain the size of the opening. Evaluate agriculture use of dykelands and potential breach of dykes, remove in areas not being utilized.

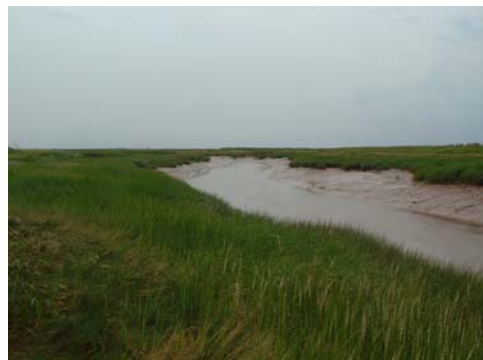
Creek: 35m wide with smooth, straight flow.

Land: Dykes along river on both sides allowing 10-20m of fringe salt marsh on either side of the river.

Figure 2. Downstream of the bridge.
