Site CCCB 22B: East Apple River

Date Assessed: July 8, Aug. 27-8,
Nov. 18, 2003

Road Crossing: 45m long steel bridge.

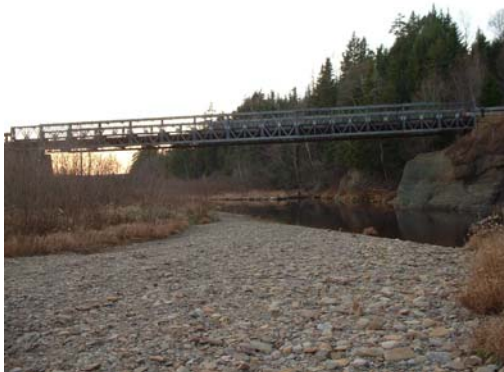
Crossing Condition: Structure is intact.

Figure 1. Upstream of bridge.

Comments: Maintain size of opening when repair or replacement is needed.
