Site CCCB 23B: Apple River

Date Assessed: July 8, Aug. 27-8,
Nov. 18, 2003

Road Crossing: 23m long concrete and wood bridge with a 4m wide support structure in the middle.

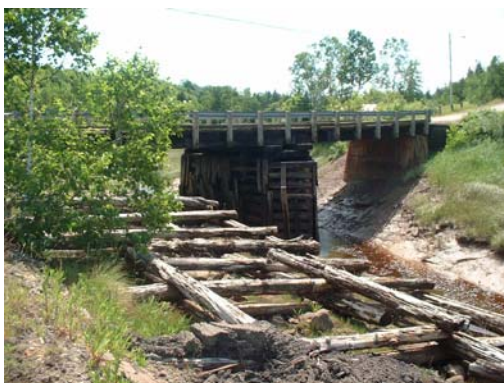
Creek: Some turbulent and divergent flow due to the 4m wide wooden bridge support in the middle of the river channel

Figure 1. Downstream of the crossing with the large wooden structure on one of the banks and the large wooden support structure under the bridge.

Comments: Maintain opening width but remove or minimize in stream bridge support structure.

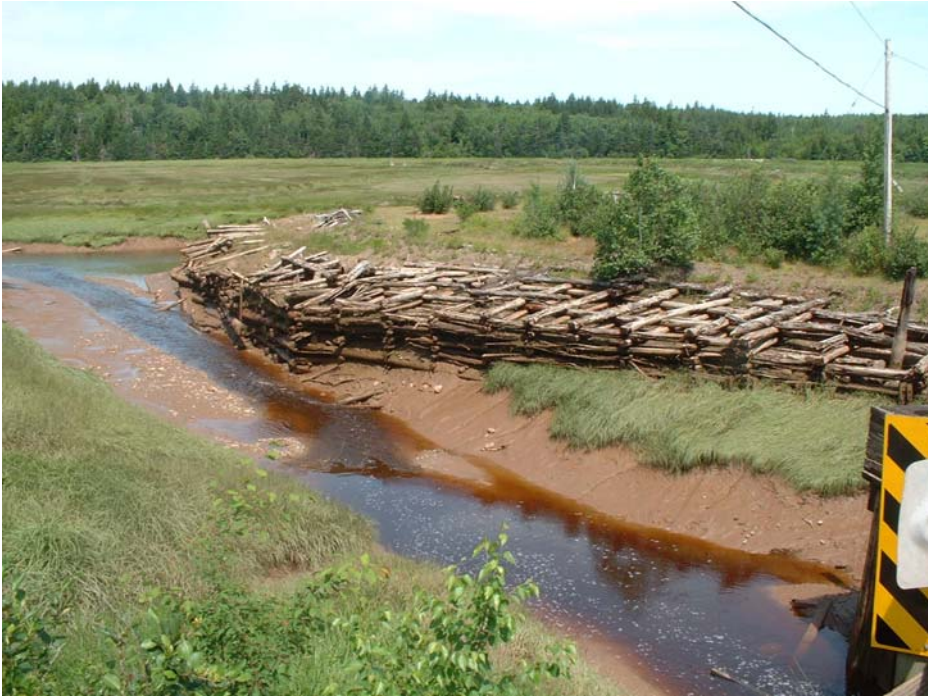
Figure 2. Old wooden structure downstream of the bridge, possibly an old wharf. DU impoundment off to the right
