Site CCCB 25B: Spicer’s Cove Brook

Date Assessed: July 8, Aug. 27-8,
Nov. 18, 2003

Crossing Status: Partial restriction.

Road Crossing: 30m long steel bridge.

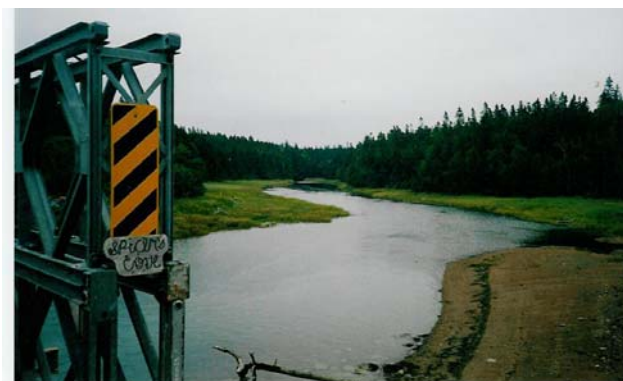
Figure 1. Upstream of the bridge. Small amount of beach to one side and the rest is salt marsh.

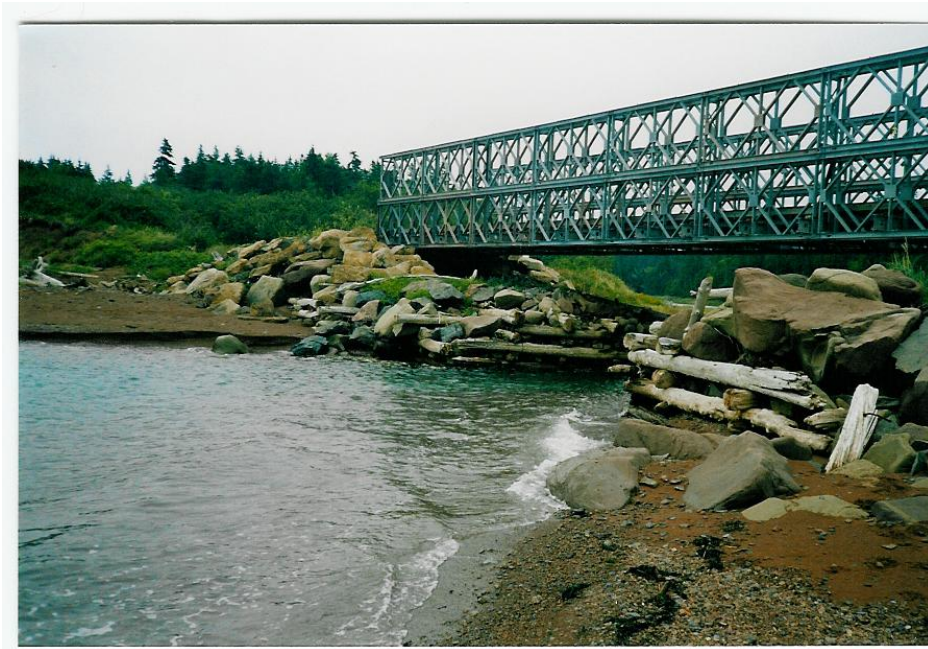
Creek: The flow is very turbulent. The banks have been built up with boulders and supported with wooden supports, and are pinching the channel.

Figure 2. Downstream view of the bridge showing the boulders and remnant material from old crossing.

Comments: Remove old crossing structure from channel under bridge to improve hydrology.

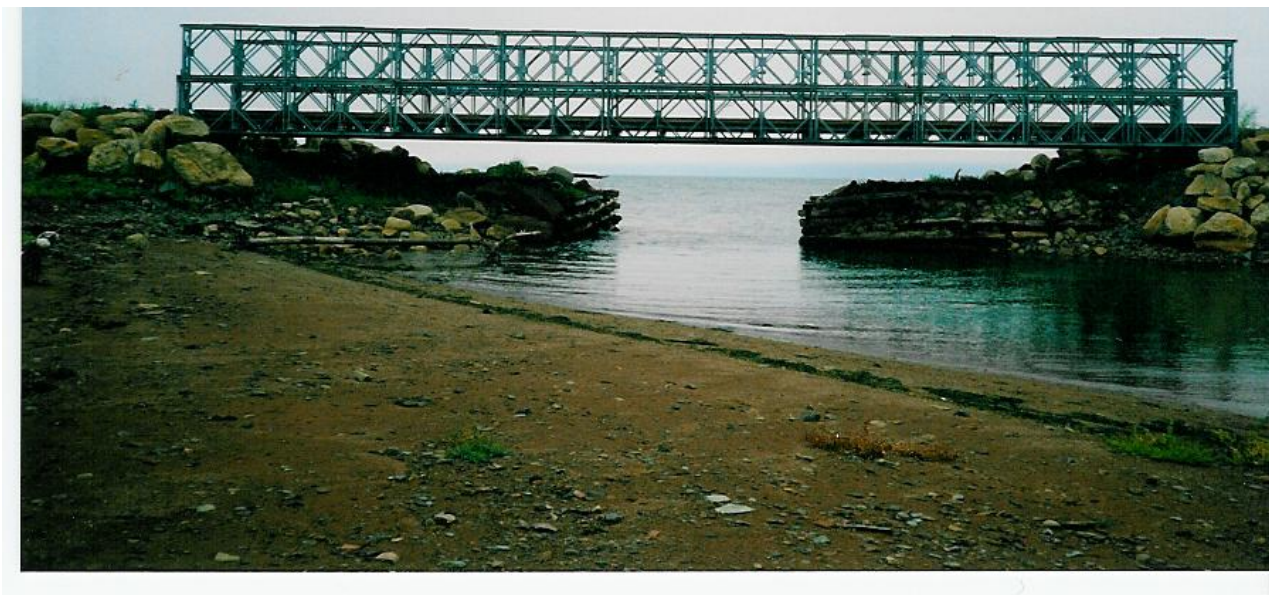
Creek: Adequate flow is getting through, but it is being forced because the channel under the bridge is too narrow.

Figure 3. The bridge from the upstream beach clearly showing the pinching of the river by the bank support structures.
