Site CCCB 5B: St. Georges Brook-Road (Maccan)

Date Assessed: August 25/26, 2003

Crossing Status: Partial restriction.

Road Crossing: 19m long wooden bridge.

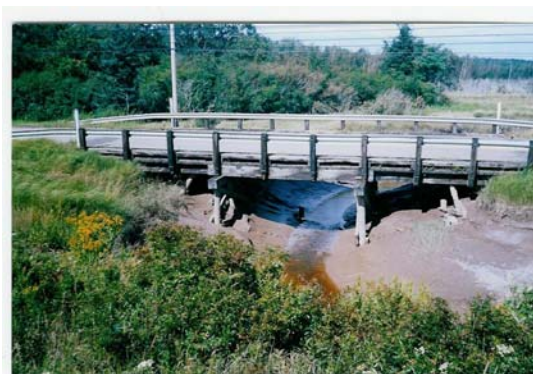
Crossing Condition: Structure is old and in considerable disrepair. This crossing is directly influenced by downstream rail crossing (CCCB6C).

Figure 1. Bridge seen from the downstream rail road. Salt marsh vegetation is visible on either side of the creek.

**Comments:** Maintain the size of the opening unless the rail crossing is replaced. In this case, the road crossing should be re-evaluated and enlarged.

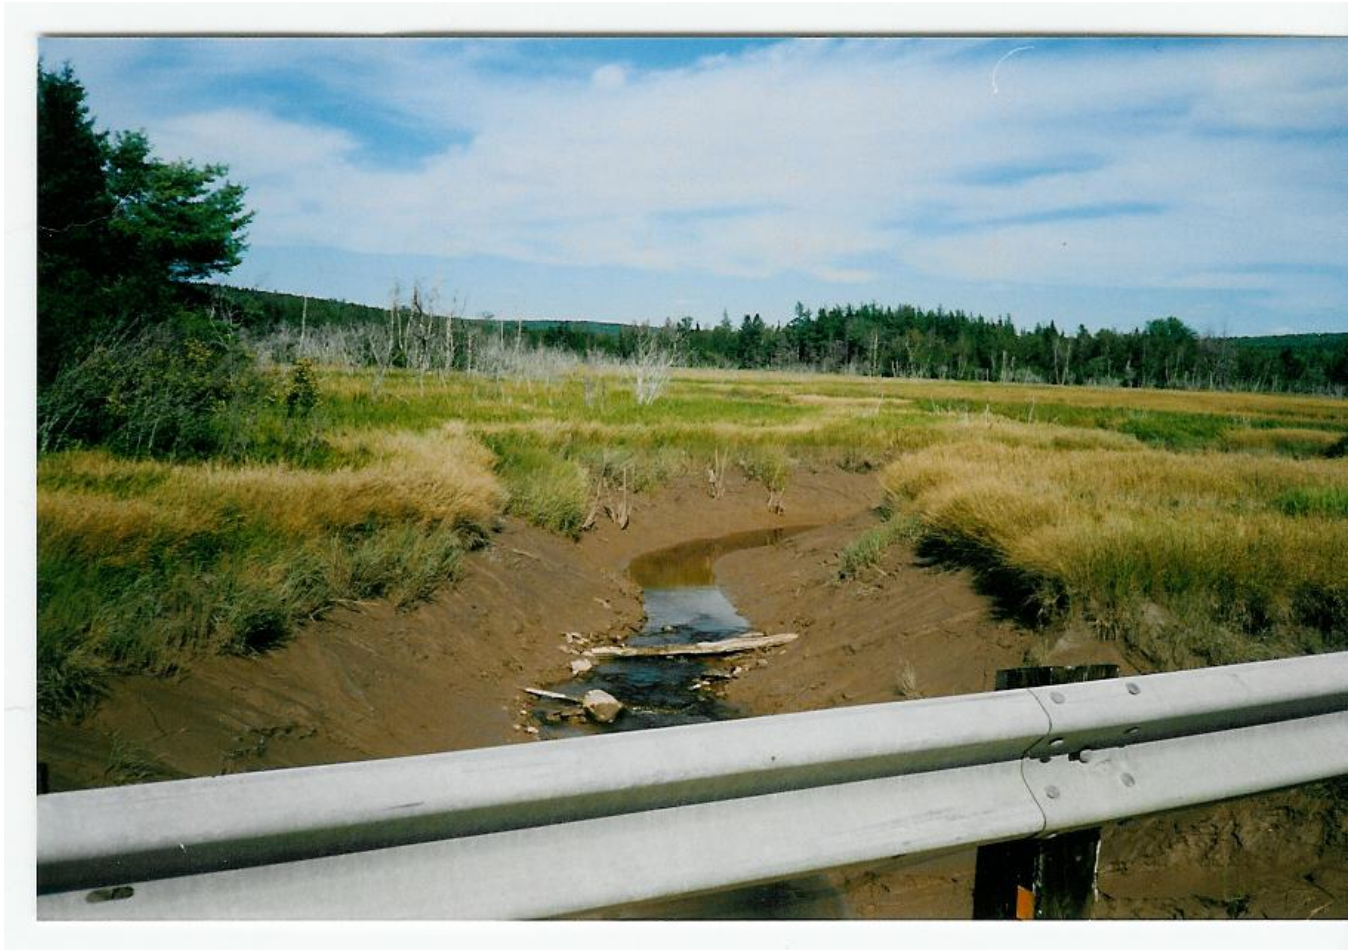
**Land:** No apparent use of land. Large wetland with remnants of dead trees on marsh surface, likely from a period when area was completely restricted.

Figure 2. Upstream of the crossing as seen from the bridge. Salt marsh plants line the banks, but remnants of dead trees are on the marsh surface. Large wetland area extending far to the right of this image.
