Site CCCB 9B: Maccan River Tributary

Date Assessed: July 8, Aug. 27-8,
Nov. 18, 2003

Road Crossing: 4m long wood bridge.

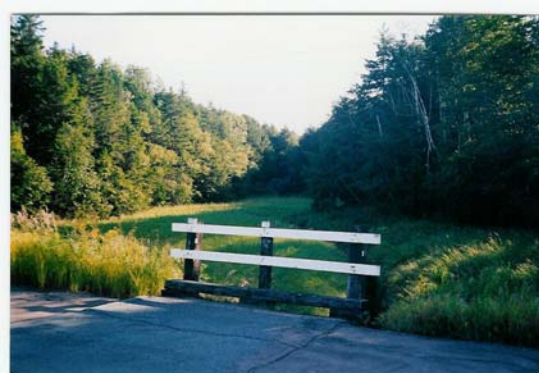
Crossing Condition: Bridge structure intact but showing serious signs of decay, road surface cracked.

Figure 1. Upstream of the crossing. There are cracks in the road, and the railing is tilting over.

Comments: Some minor repair work such as strengthening the railings. Maintain the size of the opening if replacement is ever considered. Evaluate downstream habitat for possible obstruction.

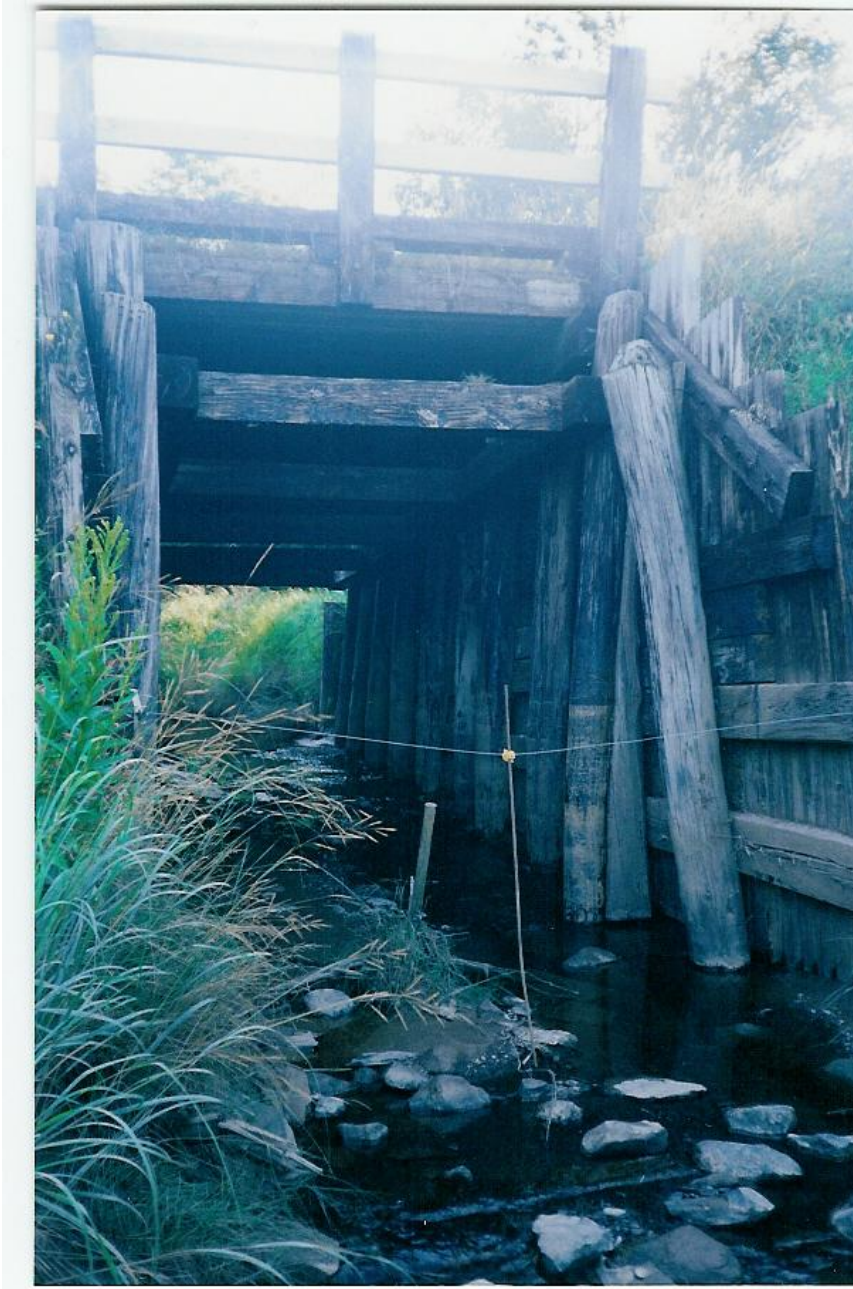
Figure 2. Under the bridge from the downstream side of the crossing. There is fencing across the creek at the bridge. Very few salt vegetation species.
