Site CCMC 29C: Spencer's Island (Hwy 209)

Date Assessed: July 8, Aug. 27-8,
Nov. 18, 2003GPS Coordinates: N 45° 21' 31.3''
W 64° 42' 45.2''

Crossing Status: Partial restriction.

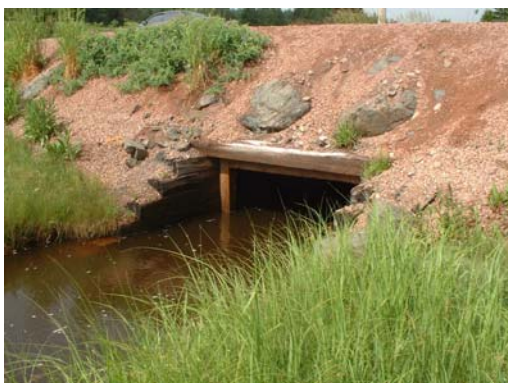
Downstream of CrossingCreek: 4-5m wide with turbulent flow
and some bank erosion.

Figure 1. Downstream view of the
culvert close to high tide.

Comments: Enlarge opening. Crossing CCMC27B and CCMC29C should be considered together and both enlarged in order to improve tidal flow and fish passage to overall system.

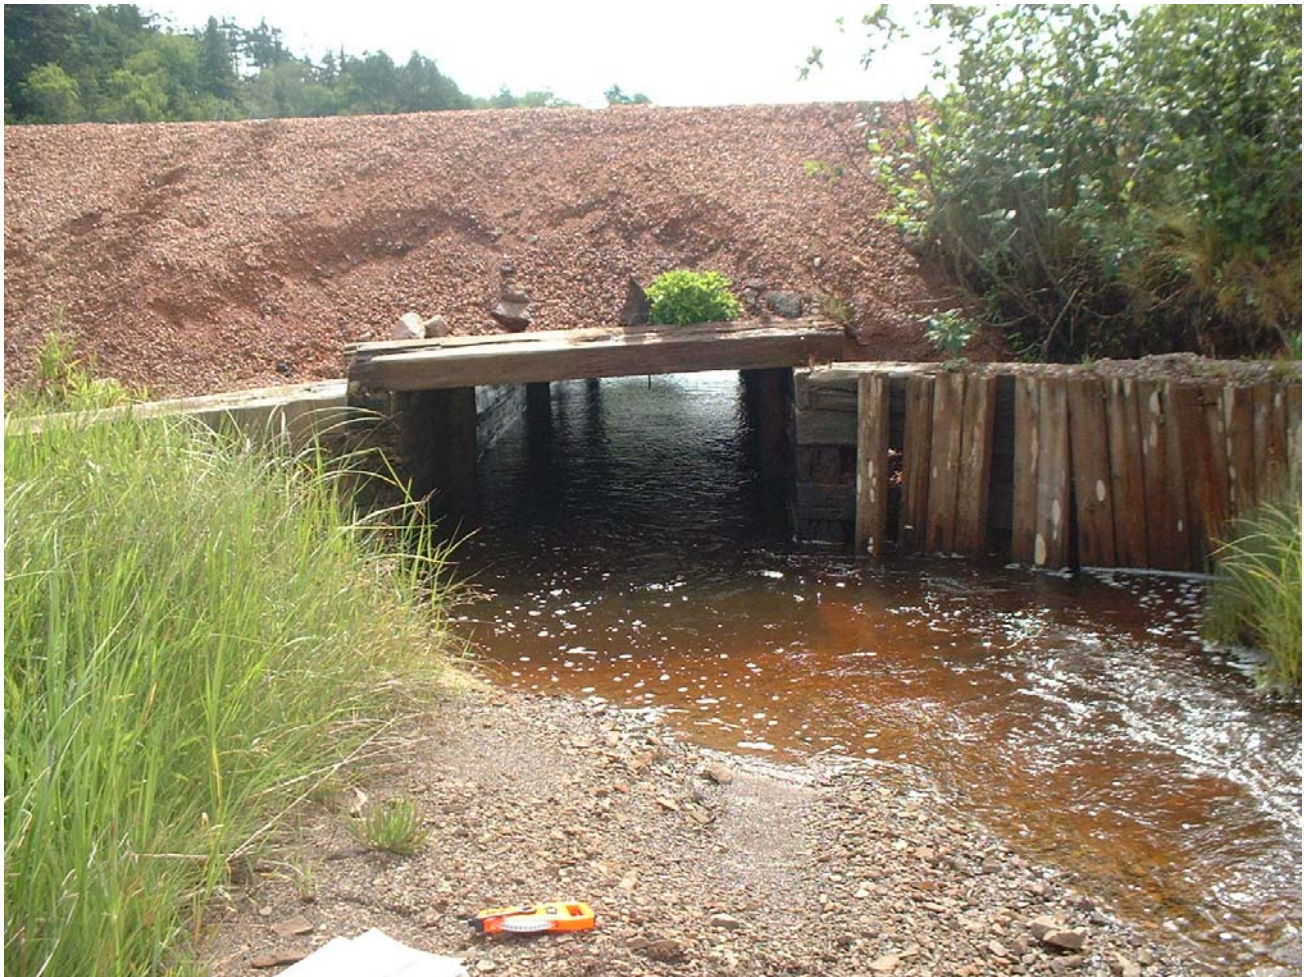
Creek: Pool in front of culvert is 6.5m wide, eddies and swirling, some bank erosion.

Figure 2. Upstream view of the culvert showing that the culvert is placed slightly off to one side with some pooling and slack water occurring to the sides of the culvert.
