Site CCMC 31C: Fowler Brook

Date Assessed: July 8, Aug. 27-8,
Nov. 18, 2003

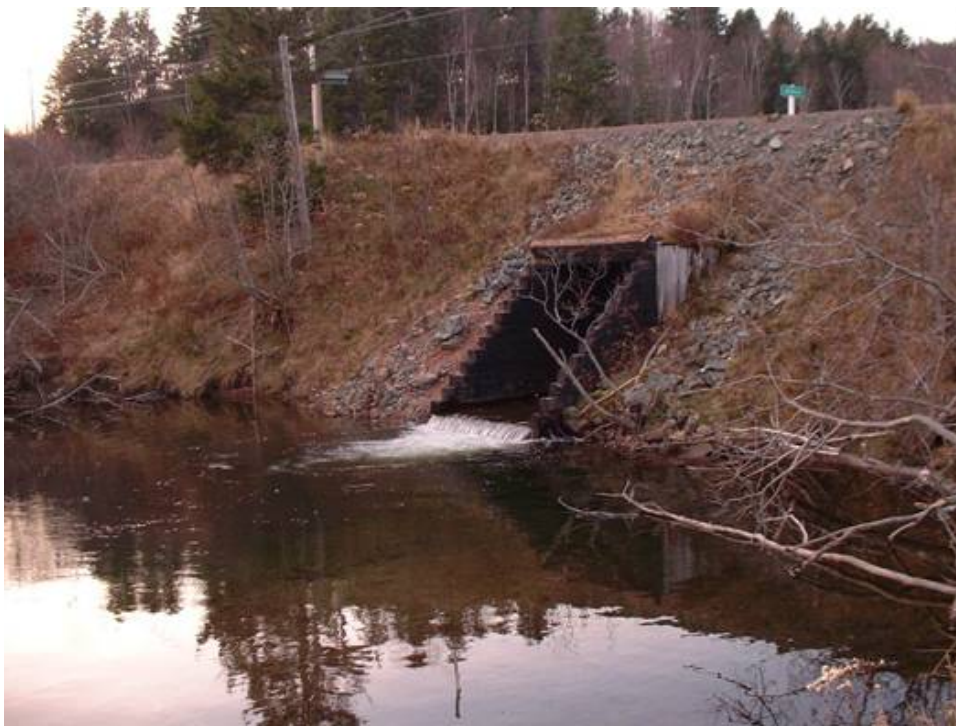
Crossing Condition: In good
condition, not flush with the creek bed
(hanging culvert).

Figure 1.
Downstream of crossing. The large pool in front of the culvert is visible as well as the high placement of the culvert.

Comments: Debris should be removed to get a better idea of how or where the river is moving. The
culvert should be lowered on the downstream side to be flush with the creek bed.

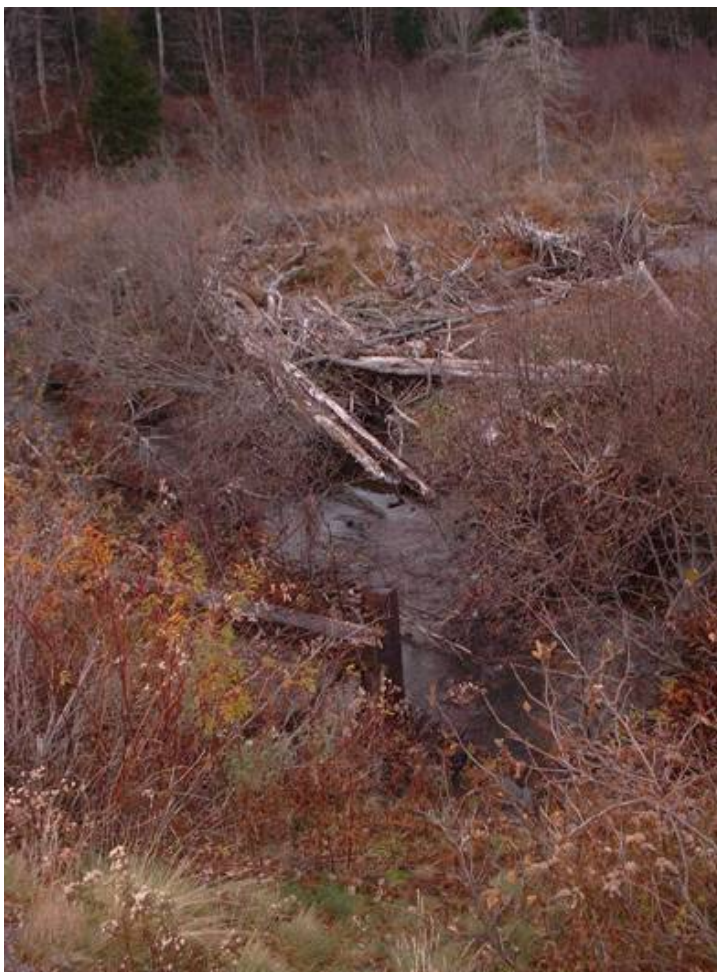
Creek: Quick rise in elevation, with beaver dams and woody debris blocking and diverting, what
seems to be, two separate channels.

Figure 2. The accumulation of debris upstream of the culvert.
