Site CCMC 32B: Fox River

Date Assessed: July 8, Aug. 27-8,  
Nov. 18, 2003

Road Crossing: 8m long wooden bridge.

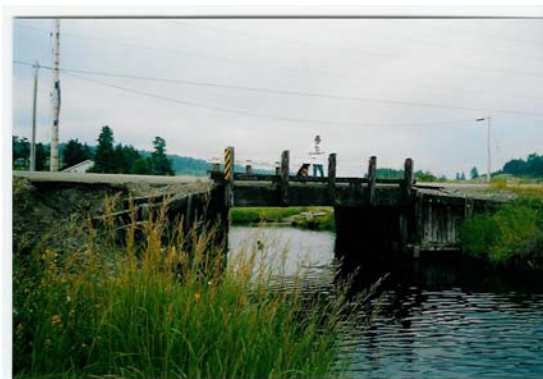
Crossing Condition: Structure is intact.

Figure 1. Downstream of crossing. The structure is slightly pinching the creek but does not appear to be significantly adversely affecting hydrology or habitat.

**Comments:** Maintain or enlarge opening when time to replace.

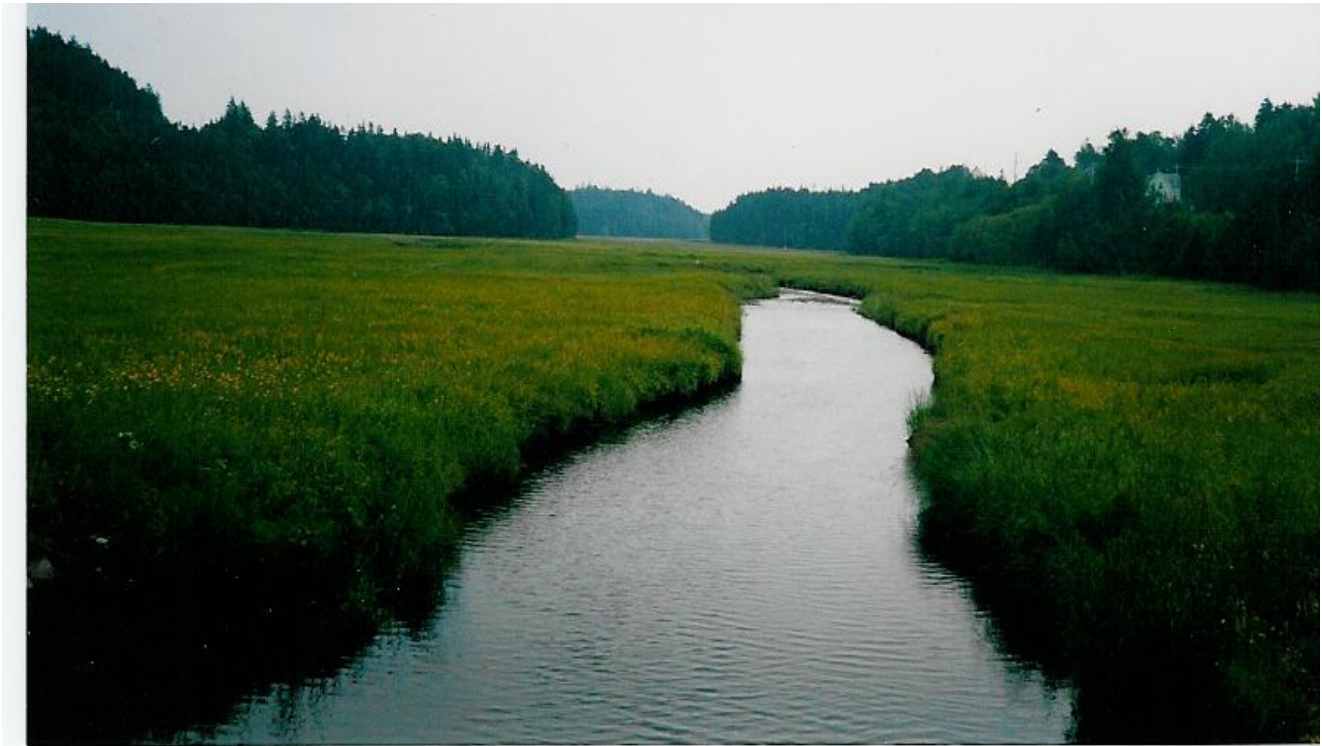
Figure 2. Downstream of crossing. Creek with salt marsh on either side.
