Site CCMC 34C: Mill Brook (Black Rock)

Date Assessed: July 8, Aug. 27-8,
Nov. 18, 2003

Crossing Status: Partial restriction.

Road Crossing: Two chambered wooded culvert with a combined opening 3 x 1.5m. .

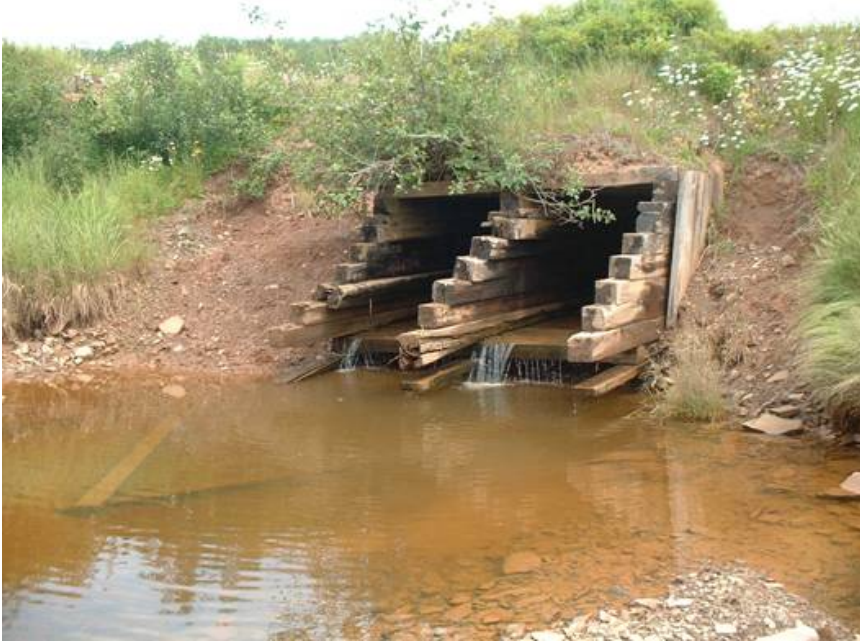
Crossing Condition: The culvert has some rotting wood and buckling, and is placed too high on the downstream side.

Creek: There is a large pool of water in front of the culvert with some erosion and a width of 10.5m.

Figure 1. Downstream view of the culvert that has not been placed flush to the creek bottom.

Comments: Enlarge and lower opening. Road appears to have built along a natural rise in elevation. Replacing the crossing with a larger opening aligned at both ends with the stream bottom or installing an open bottom structure would improve hydraulic flow and fish passage.

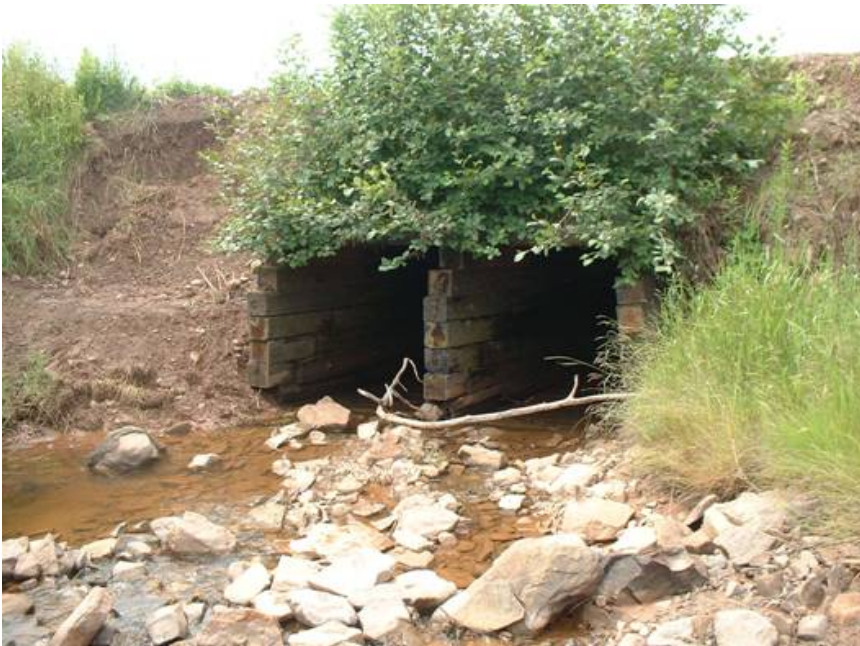
Creek: Channel is 5m wide and there is a swift rise in elevation.

Figure 2. Upstream of crossing. Natural rise in elevation is the main reason for the limited tidal intrusion.
