**Site CCMC 35B:** Farrells Brook (Parrsboro)

**Date Assessed:** July 8, Aug. 27-8,  
Nov. 18, 2003

**Crossing Status:** Partial restriction

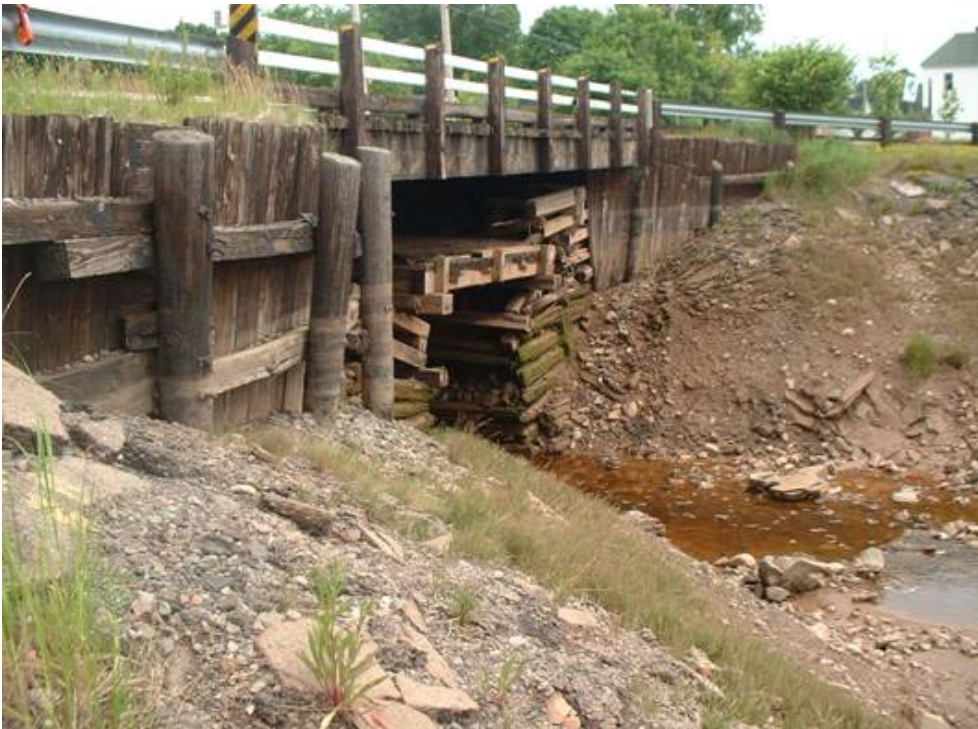
**Crossing Condition:** New bridge in good repair but remnants of old bridge in considerable state of disrepair.

Figure 1.  
Downstream view  
of the bridge with  
the old structure  
visible under  
bridge.

**Comments:** Enlarge opening by removing remnants of old bridge.

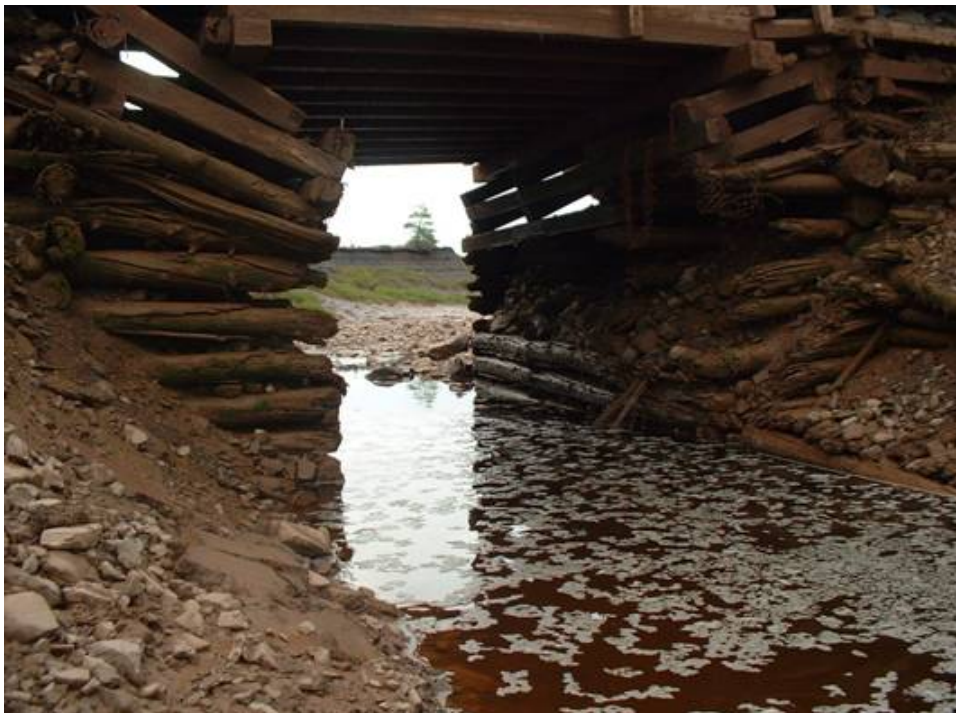
**Creek:** Channel is 5 to 5.5m in width confined by remnants of the old bridge and an old dam. A slight scour pool and some bank erosion are apparent.

Figure 2.  
Upstream looking  
down under  
bridge. The old  
bridge is pinching  
the river channel.
