Site DC10C: Walsh Brook (Acacia Valley)

Date Assessed: 26/08/04

Crossing Status: Partial restriction

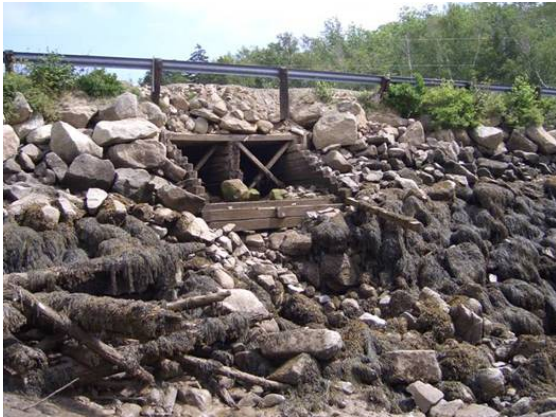
Crossing Condition: In disrepair
and filled with debris

Figure 1. Downstream view of crossing. Culvert is filled with debris and placed high above creek bottom with large amount of rock and wooden debris.

Comments: The culvert is in a state of disrepair and filled with debris. The guardrail at the road is falling over and is a potential safety issue. This culvert is too small and placed too high in the creek bed to allow for adequate flow of water and species. Large boulders and debris are caving in around the crossing. There are remnants of an old wooden structure along the side of the creek just in front of the downstream end that could be removed, although these may not be a significant obstruction. Culvert needs to be replaced with a larger opening that is positioned lower on the river bottom.

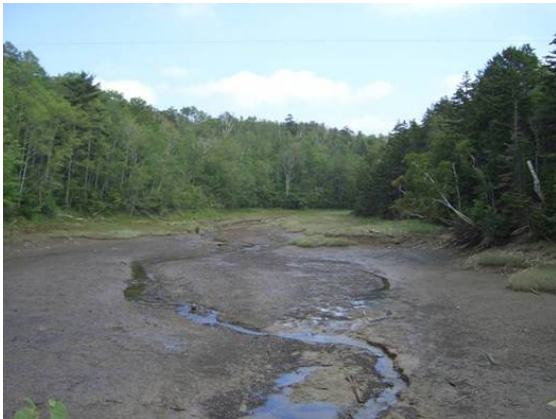
Figure 2. Upstream of crossing

Creek: Straight flow, scour pool and slack water.

Land: Small marsh bordered by forest.

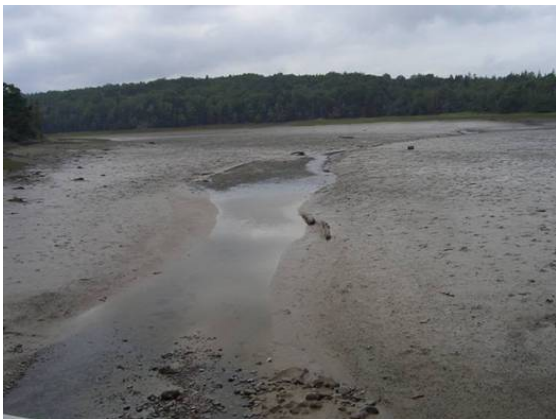
Creek: Tributary of main channel,
scour pools and slack water.

Figure 3. Downstream of crossing, opens into main river channel.
