Site DC11B: Acacia Brook (Acacia Valley)

Date Assessed: 26/08/04

Road Crossing: Bridge (concrete/wood) with steel rail, 17m

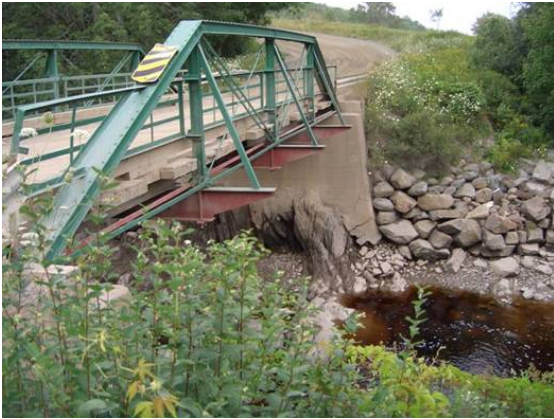
Comments: Crossing is not restricting tidal flow or fish passage. Maintain size of opening.

Figure 1. Downstream view of crossing

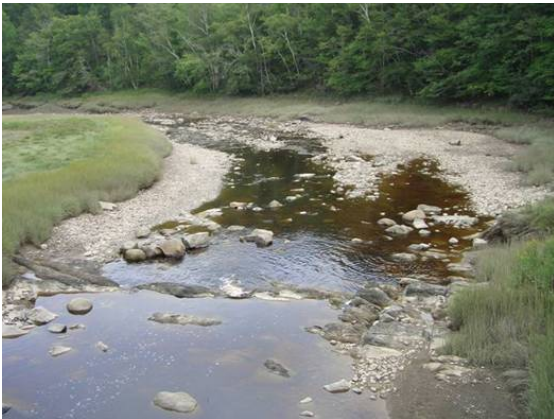
Creek: 15m wide, rocky bottom, straight flow. Mouth of river is crossed by DC9B further downstream.

Land: Some marsh vegetation along edges of brook. Some cabins and a boat launch further downstream.

Figure 2. Downstream of crossing

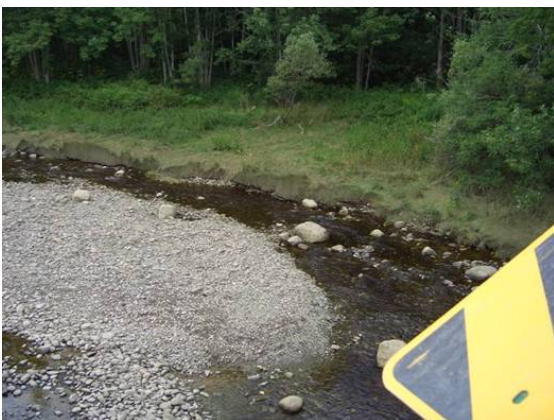
Creek: 15m wide, rocky bottom, straight flow.

Land: Mostly wooded.

Figure 3. Upstream of crossing
