Site DC12C: Little Joggins

Date Assessed: 26/08/04

Road Crossing: Culvert (concrete), 1m

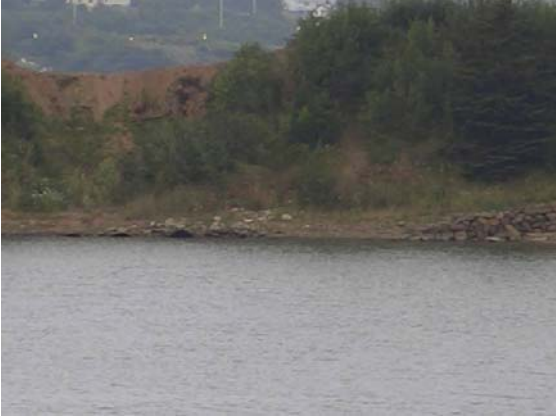
Figure 1. Downstream of crossing. This channel joins the larger creek.

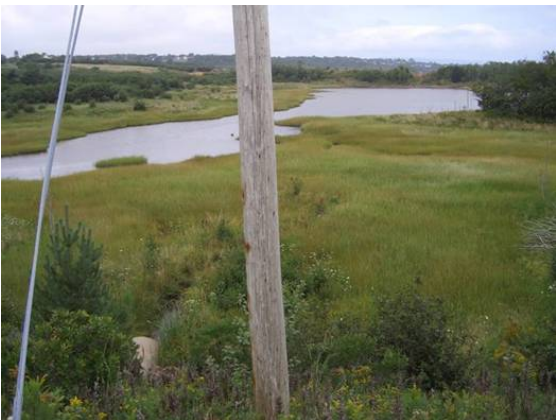
Figure 2. Further downstream of crossing there is a causeway separating this area from the Basin. Could not access this barrier or assess any culvert(s) underneath is.
