Site DC16C: Freeport (School St.)

Date Assessed: 26/08/04

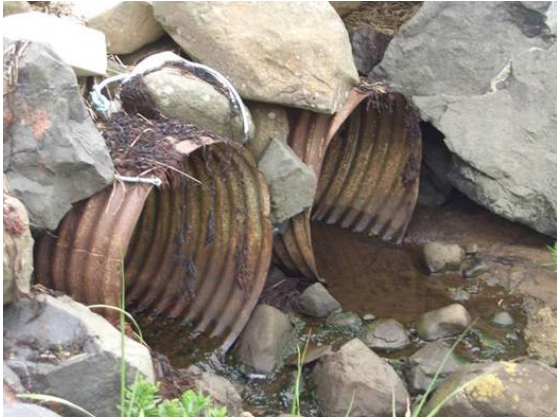
Crossing Condition: In poor condition and rusted

Figure 1. Downstream view of crossing. Culverts are old, rusted and collecting debris.

Comments: Replace culverts which are in need of repair, with a single larger opening to restore natural tidal flow.

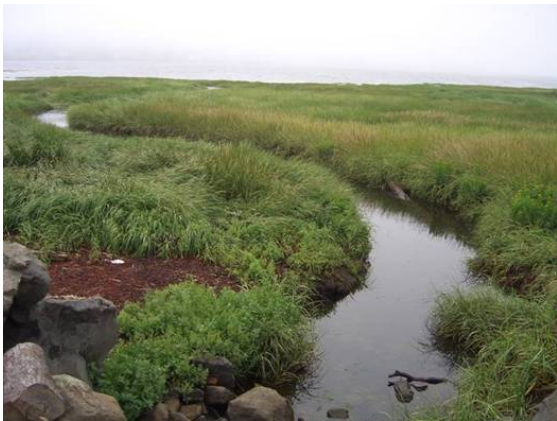
Figure 2. Downstream of crossing

Creek: 1m wide, smooth straight flow.

Land: Salt marsh.

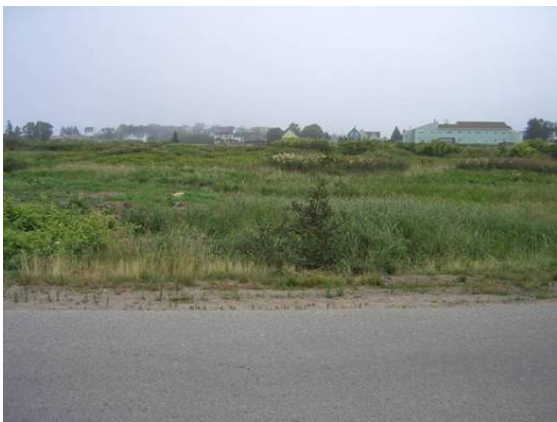
Figure 3. Upstream of crossing

Creek: 0.5m wide, straight flow.

Land: Marsh vegetation, residential.
