Site DC20C: Haight Brook

Date Assessed: 26/08/04

Road Crossing: Culvert
(wooden/square), 2.5m

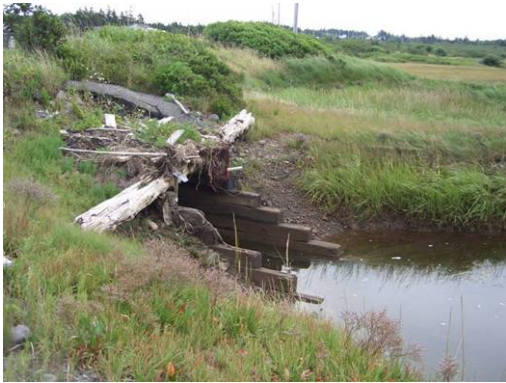
Comments: Debris has built up around and on top of culvert and it is in disrepair. The opening should be enlarged to restore natural tidal flow and increase fish passage.

Figure 1. Downstream view of culvert

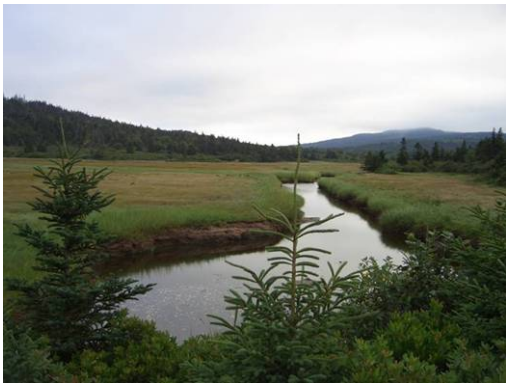
Creek: 4m wide with scour pool and bank slumping.

Figure 2. Upstream of crossing

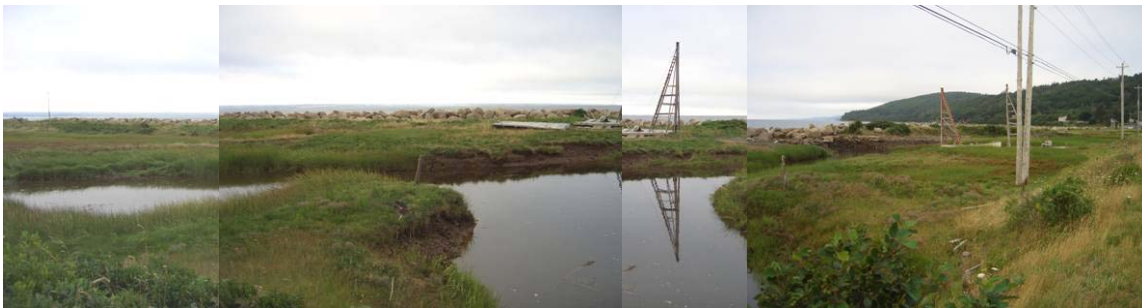
Creek: 6m wide with large scour pool.
Channel has been diverted through a
seawall running parallel to the beach.

Figure 3. Downstream of crossing showing scour pool to the left (east) of the crossing. Main channel flows out through the seawall.
