**Site DC22A:** Henderson Brook

**Date Assessed:** 26/08/04

**Road Crossing:** Aboiteau (upstream end: concrete/square with two round openings)

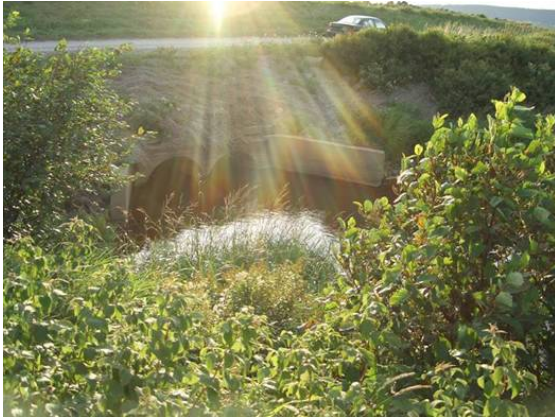
**Crossing Status:** Complete restriction

**Crossing Condition:** Intact

**Figure 1.** Upstream view of crossing

**Comments:** This land is currently being used for farming and cattle grazing therefore replacement of the aboiteau may not be possible. Should the land no longer be used for this purpose the aboiteau should be replaced with a culvert to restore natural flooding and fish passage. This crossing should be considered along with crossing DC21A since they are part of the same area of farmland.

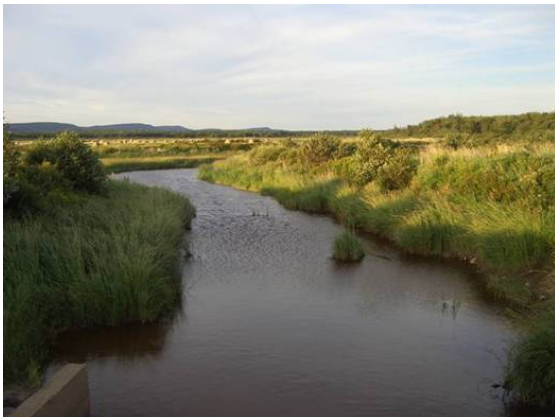
**Figure 2.** Upstream of crossing
