Site DC26B: Sissiboo River (Weymouth Harbour)

Date Assessed: 26/08/04

Road Crossing: Bridge (concrete), 150m

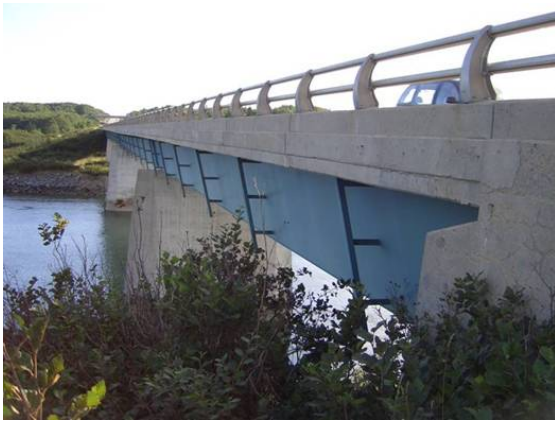
Figure 1. Upstream view of crossing

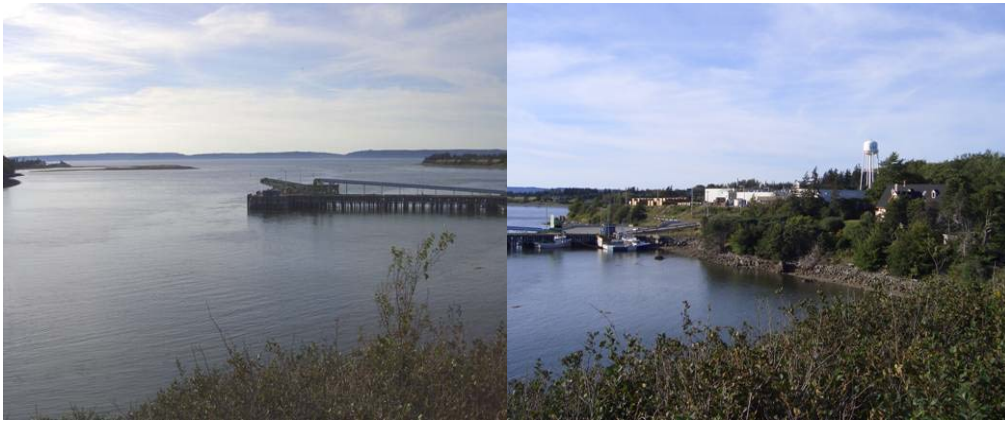
Creek: Large river approximately 100m wide, straight flow with some turbulent water (eddies) near base of support structures. There is an inlet on north side of the bridge, next to wharf.

Land: There is a harbour just downstream of bridge that extends into the river channel.

Figure 2. Downstream of crossing showing harbour and wharf.

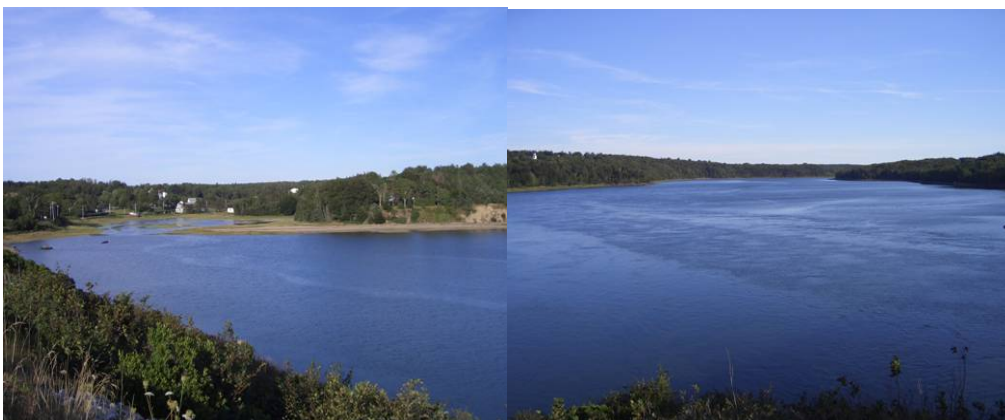
Creek: Large river approximately 100m wide, straight flow with some turbulent water (eddies) near base of support structures. There is an inlet on north side of the bridge.

Land: Some marsh vegetation bordered by forest and some residences on north side.

Figure 3. Upstream of crossing showing inlet with bordering residences.
