Site DC27B: Sissiboo River (Weymouth)

Date Assessed: 26/08/04

Crossing Status: Partial restriction

Road Crossing: Bridge (concrete), 76m

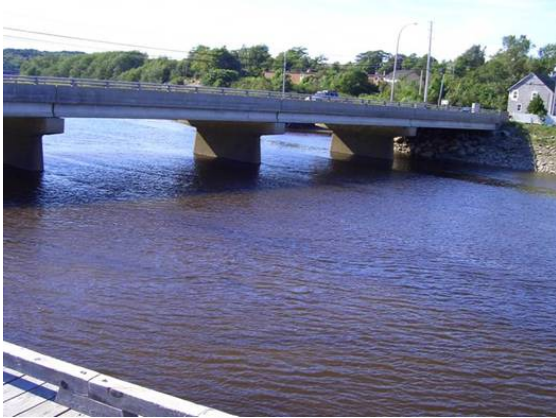
Comments: This is a large bridge spanning the width of the river however the support structures in the river channel are large and remnants of an old wooden structure appear to be causing some restriction to tidal flow. Removal of this obstruction should be considered as well as reducing size of support structures when repairing the bridge.

Figure 1. Upstream view of crossing.

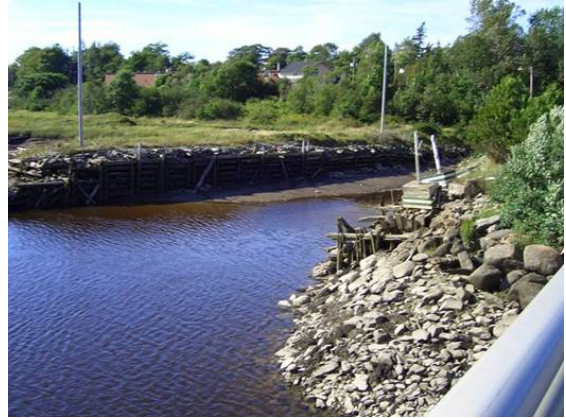
Creek: 70m wide, with scour pooling and bank slumping.

Figure 2. Downstream scour pool.

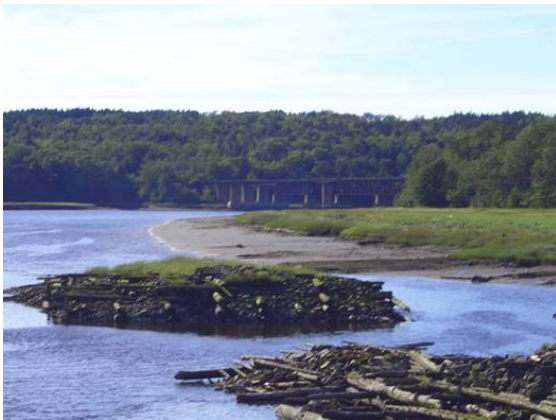
Land: Some salt marsh vegetation bordered by forest. Crossing in on the main road which runs through the business section of town. There is a rail bridge downstream along with remnants of an old wooden structure (wharf?) in the creek bed.

Figure 3. Downstream rail bridge and remnants of old wharf.

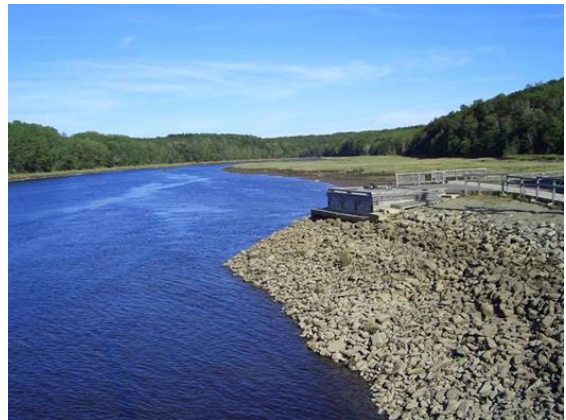
Creek: 70m wide, with scour pooling and bank slumping.

Figure 4. Upstream of crossing.
