Site DC29B: Issacs Lake Brook (Belliveaus Cove Wharf)

Date Assessed: 26/08/04

Crossing Status: No restriction

Road Crossing: Bridge (wooden), 3m

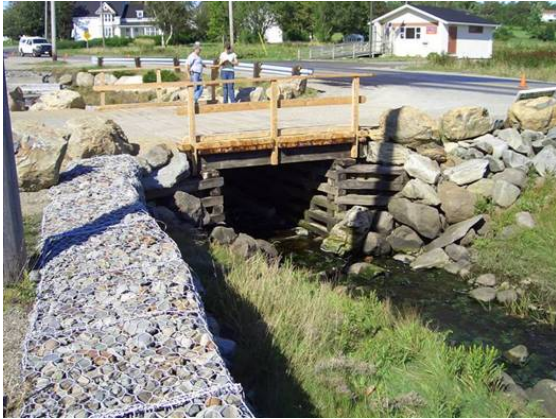
Creek: Natural channel diverted to flow parallel to the road and through site DC30C. There is some bank slumping and turbulent flow with eddies.

Figure 1. Upstream view of crossing
