**Site DC2C:** Chisholm Brook (Bear River tributary)

**Date Assessed:** 26/08/04

**Crossing Status:** Partial restriction

**Road Crossing:** Culvert (wooded/double square), 3.7m

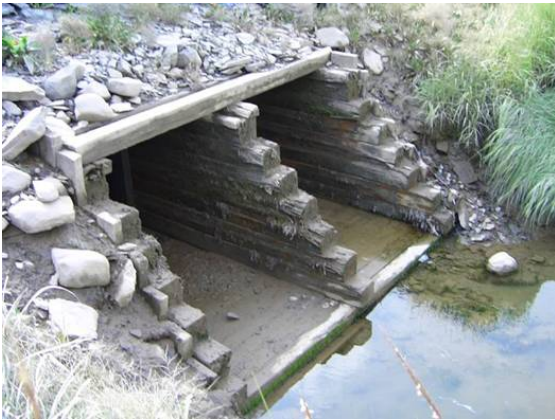
**Crossing Condition:** Intact but showing some wear and gathering debris

**Figure 1.** Downstream view of crossing branches from main channel of Bear River

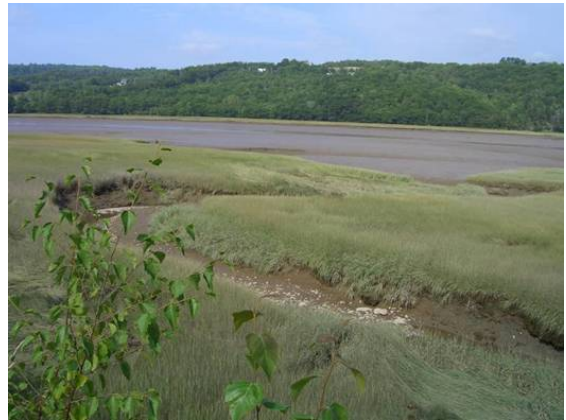
**Creek:** 4m wide, straight smooth flow, tributary of Bear River.

**Figure 2.** Downstream of crossing, creek

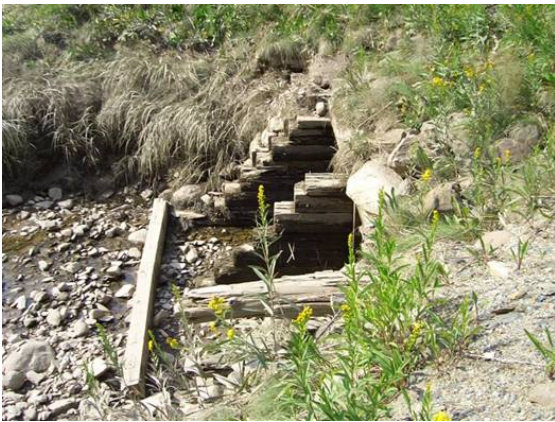
**Figure 3.** Upstream view of crossing, some debris around opening

**Comments:** This crossing does not have a significant impact on tidal flow, and with the rise in elevation just upstream there is not a large potential for salt marsh restoration. When culvert is to be replaced enlarging the size of opening should be considered and at the very least be maintained.

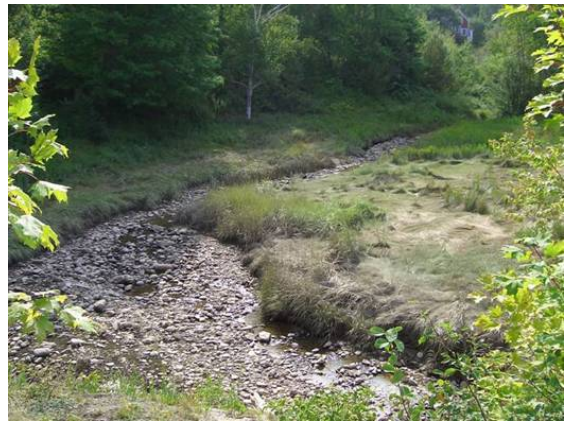
**Creek:** 3m wide, scour pool.

**Land:** Small marsh bordered by forest.

**Figure 4.** Upstream of crossing, small marsh area that rises in elevation
