**Site DC30C:** Issacs Lake Brook (Belliveaus Cove)

**Date Assessed:** 26/08/04

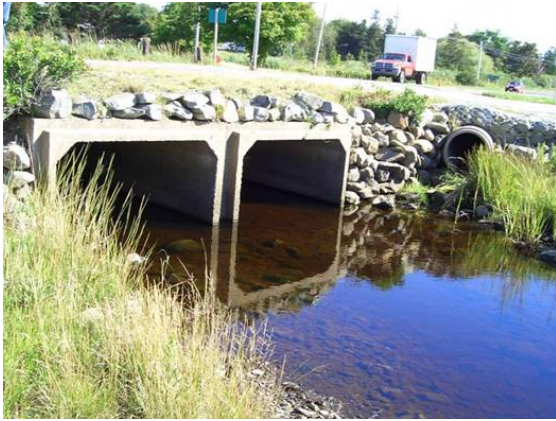
**Downstream of Crossing**

**Creek:** 4m width, divergent from original path. Channel flows along the ditch of Route 1 upstream of crossing DC29B.

**Figure 1.** Downstream view of crossing

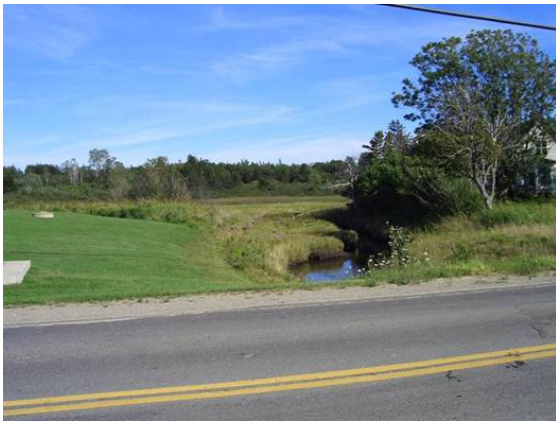
**Creek:** 3m width, scour pool

**Figure 2.** Upstream of crossing

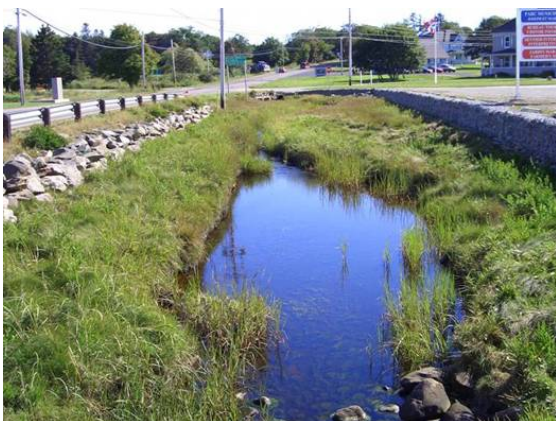
**Comments:** This brook appears to be diverted by the harbour and road to flow through the ditch area next to the main road. This crossing however, does not pose a restriction.

**Figure 3.** Looking towards the downstream side of crossing from DC29B.
