Site DC36B: Duffy Brook

Date Assessed: 26/08/04

Road Crossing: Culvert (concrete) square open bottom, 3m

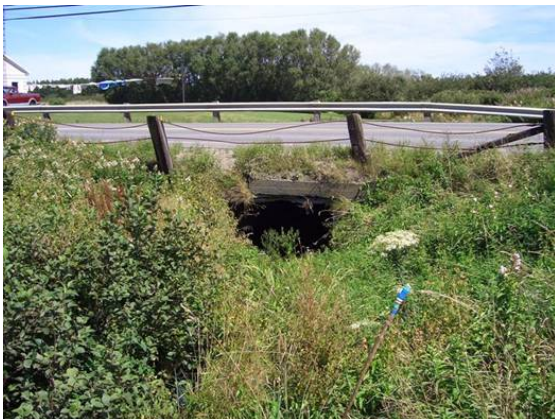
Figure 1. Downstream view of crossing.

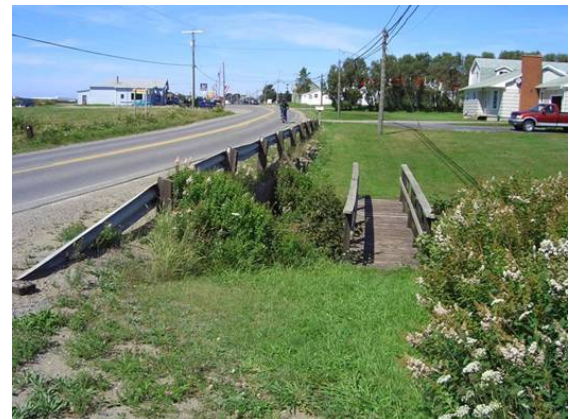
Figure 2. Upstream of crossing showing walking bridge
