**Site DC37B:** Duffy Brook

**Date Assessed:** 26/08/04

**Road Crossing:** Bridge (wooden), 2.7m

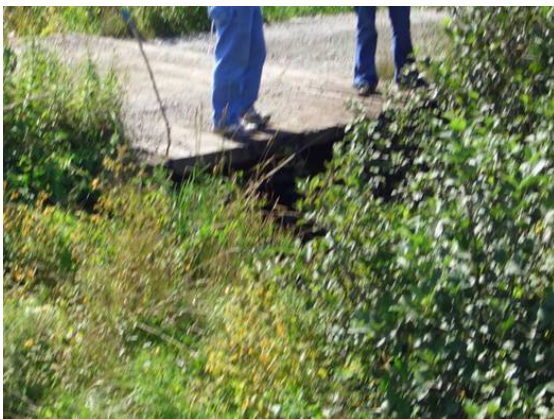
**Comments:** This crossing is along a dirt road off route 1 next to crossing DC36B. It not poses to restriction to flow and due to the downstream aboiteau is no longer tidal.

**Figure 1.** Upstream view of crossing
