**Site DC38B:** Germain's Brook

**Date Assessed:** 26/08/04

**Road Crossing:** Bridge (wooden) with footbridge on upstream side, 3.5m

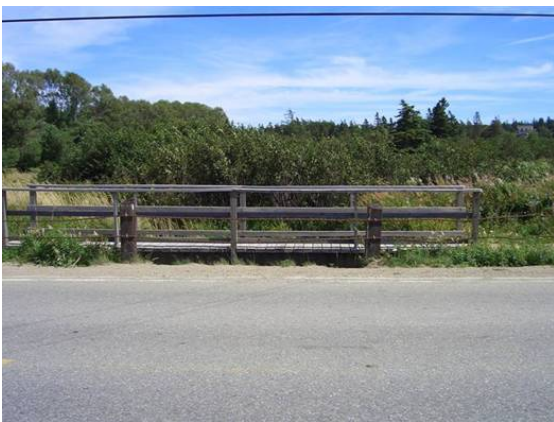
**Creek:** 2m wide, smooth straight flow. Footbridge next to crossing wider than bridge, no restriction from this. Drainage culvert next to bridge flowing into river.

**Figure 1.** Upstream of crossing

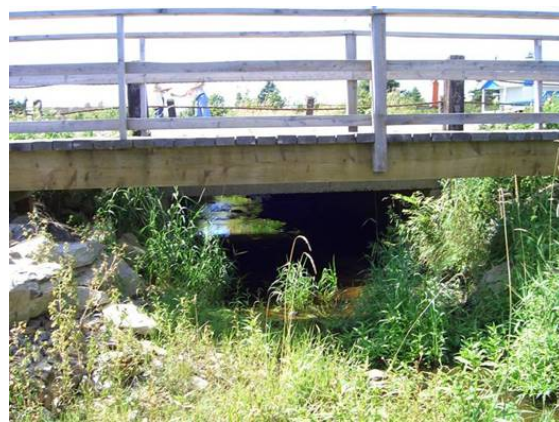
**Crossing Condition:** Intact

**Figure 2.** Upstream view of crossing showing foot bridge

**Comments:** No salt marsh restoration potential. Maintain the size of opening upon repair to ensure adequate fish passage. Downstream there is a maintained estuary which is reached by salt water on high tides.
