Site DC40B: Metaghan River

Date Assessed: 26/08/04

Road Crossing: Bridge (steel/concrete), 45.5m

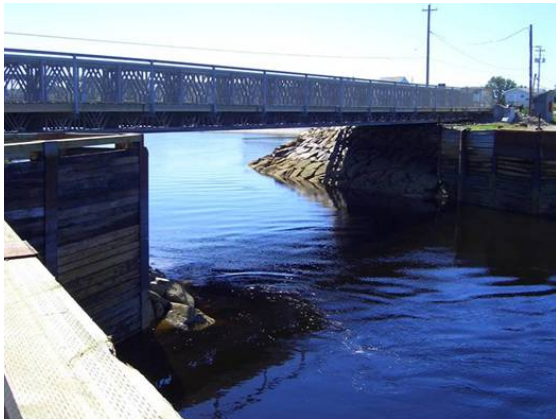
Figure 1. Downstream view of crossing

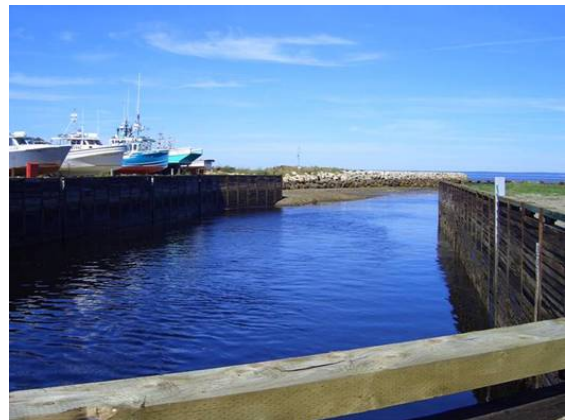
Comments: Channel is diverted by the jetty and wharf downstream, however there is not a huge restriction. Bridge does pinch the river slightly; however there is little restoration potential due to usage of the wharf.

Figure 2. Downstream of crossing showing wharf and jetty

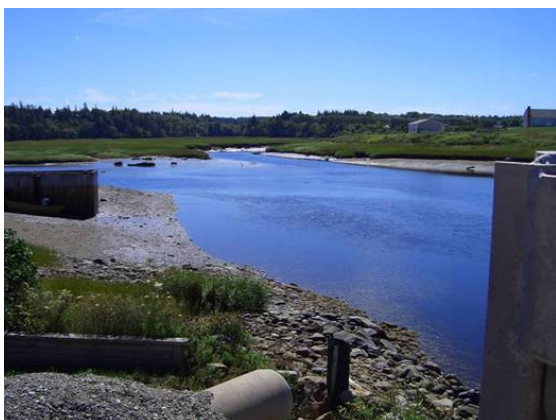
Figure 3. Upstream of crossing, river divides just upstream of crossing. Old structure is visible in picture

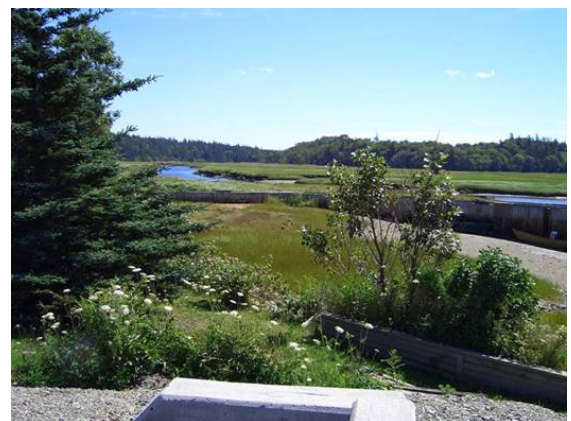
Figure 4. Upstream of crossing
