**Site DC41C:** Mavillette Brook

**Date Assessed:** 26/08/04

**Road Crossing:** 2 Culverts (corrugated) next to one another, 1.5m each

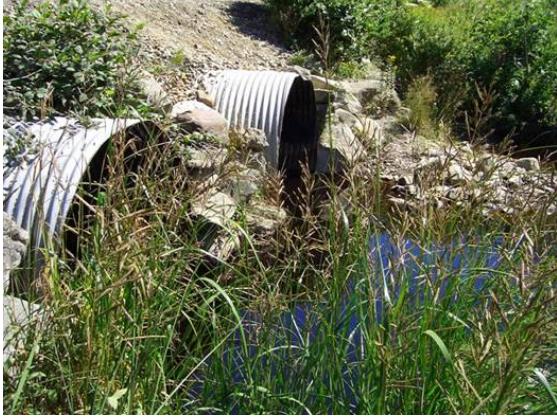
Bank slumping  
Scour pool

**Figure 1.** Downstream view of crossing showing erosion of rocks from bank around culverts

**Comments:** There is little salt marsh area to be restored but fish passage would be improved with a single large opening. The crossing is at the tidal edge of the Cape St. Mary's marsh system and therefore tidal flow may not be an issue.

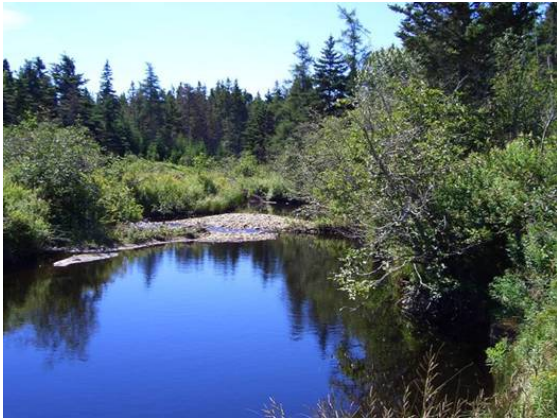
**Figure 2.** Downstream of crossing bordered by forest.

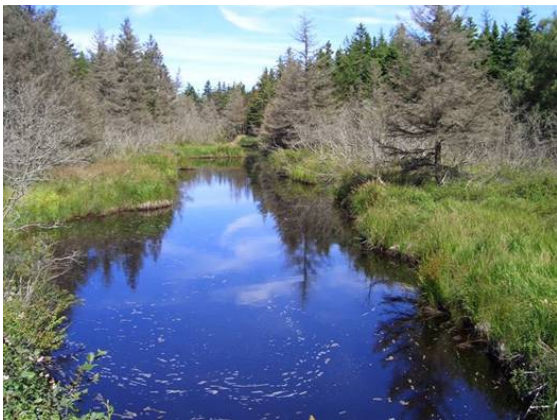
**Figure 3.** Upstream of crossing bordered by forest.
