**Site DC43B:** Mavillette River

**Date Assessed:** 26/08/04

**Road Crossing:** Culvert (concrete), square open bottom, 5m

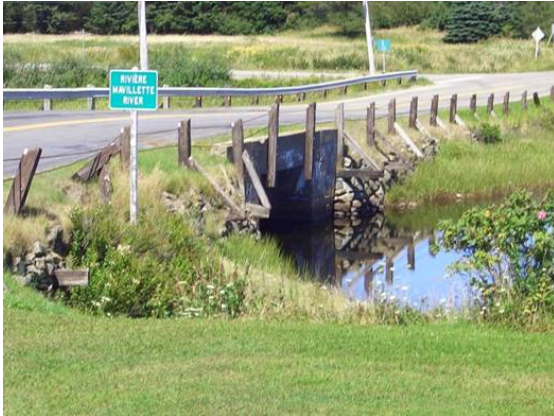
**Figure 1.** Upstream view of crossing

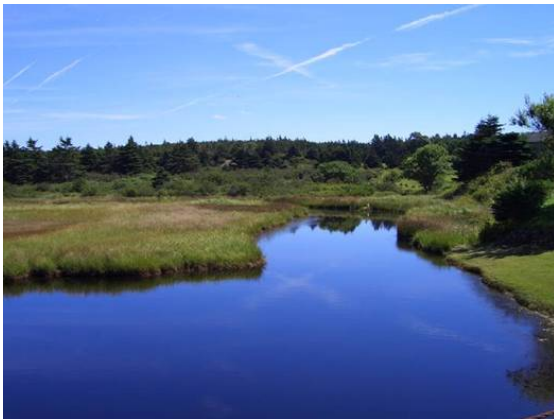
**Creek:** 15m width, large scour pool at crossing, stream path diverges from the crossing.

**Figure 2.** Upstream of crossing showing large scour pool

**Comments:** Enlarging this opening would improve tidal flow to the system. The current opening is only 5m which is much smaller than the channel width on either side. Since this crossing is part of the Cape St. Mary's marsh it should be considered in combination of the other crossings downstream.

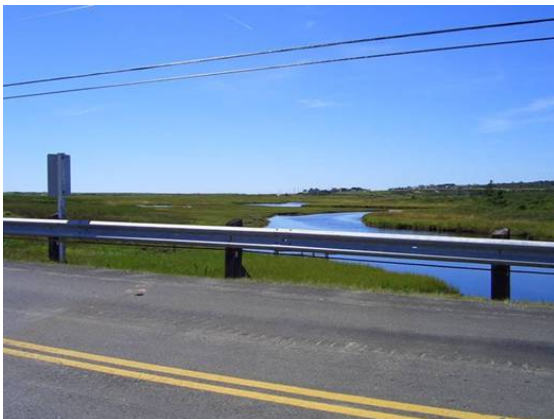
**Creek:** 20m stream width with scour pools and slack water, angular flow.

**Figure 3.** Downstream of crossing, large marsh system leading to DC44B and DC45B
