Site DC44B: Cape St. Mary's

Date Assessed: 26/08/04

Crossing Status: Partial restriction

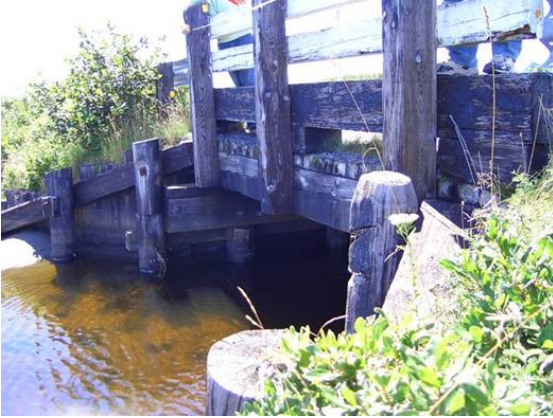
Crossing Condition: Intact but showing wear

Restriction Indicators:
Scour pool

Figure 1. Downstream view of crossing

Comments: Bridge is not causing a substantial restriction to flow, however scour pools are present on both sides of the crossing and the length of the opening is less than the stream width, and therefore opening could be widened when repair is necessary. Since this crossing is upstream of DC45B, both should be considered at the same time.

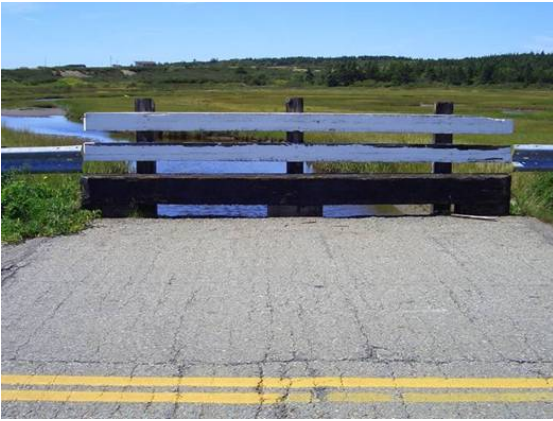
Creek: 4m stream width with scour pool and angular flow.

Land: Salt marsh.

Figure 2. Downstream of crossing

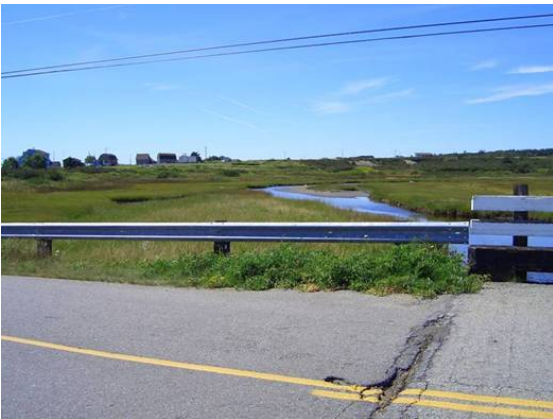
Creek: 4m stream width with scour pool and angular flow.

Land: Salt marsh.

Figure 3. Upstream of crossing
