Site DC 45B: Cape St. Mary's

Date Assessed: 26/08/04

Crossing Status: Partial restriction

Road Crossing: Bridge (wooden), 5m

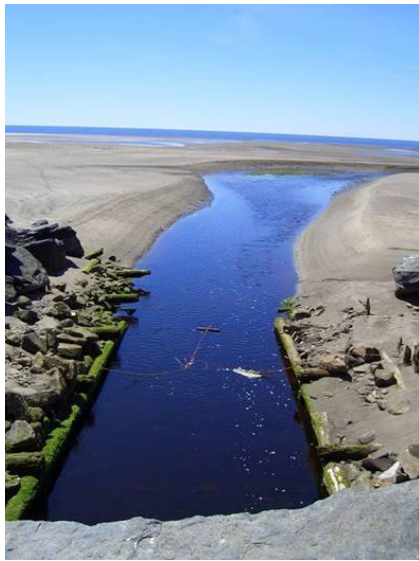
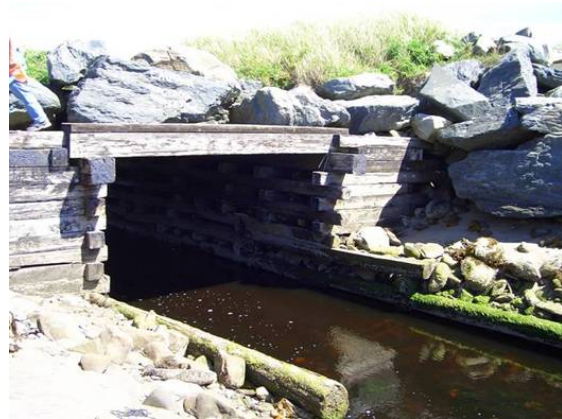
Creek: Channel has been diverted to this crossing which opens up onto the beach/ocean. Channel is 4m wide at mouth of bridge which has wooden structures extending 6m out along the edges of the creek. There are large boulders around base of crossing.

Figure 1 and Figure 2. Downstream view of crossing

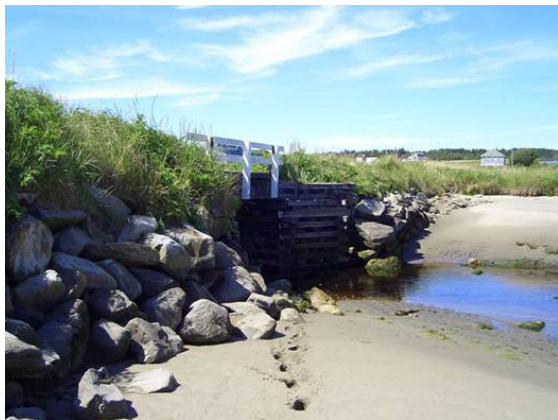
Comments: This stream has been channeled through the crossing which is partially restricting tidal flow. Opening should be widened and replaced in line with the natural channel. If this occurs upstream crossing would need to be reassessed.

Figure 3. Upstream view of crossing. Large boulders support the banks from erosion.

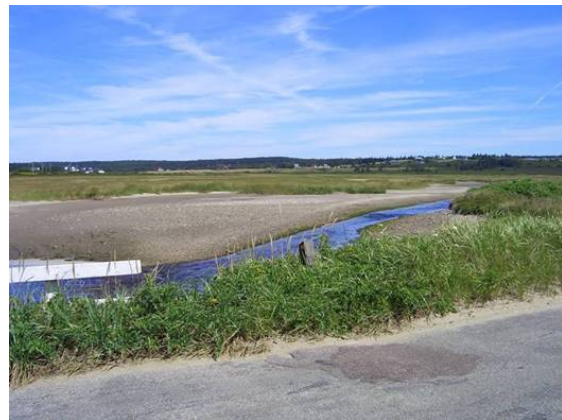
Creek: Stream width is approximately 25m right at crossing opening where there is a large scour pool and bank slumping is occurring. Channel makes a sharp turn from the scour pool leading to a number of crossings upstream.

Figure 4. Upstream marsh system. There is a large scour pool where channel diverges.
