**Site DC46B :** Bowman Brook

**Date Assessed:** 26/08/04

**Road Crossing:** Bridge (wooden), 5.5m

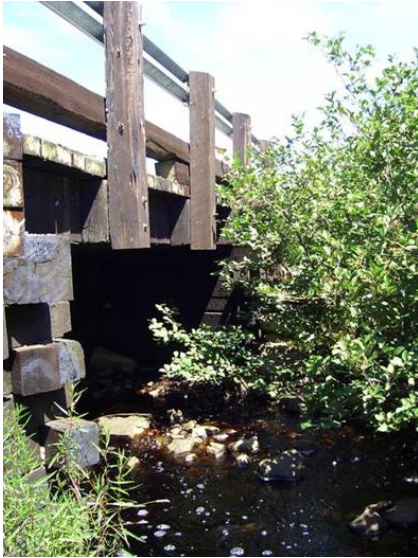
**Figure 1.** Downstream view of crossing

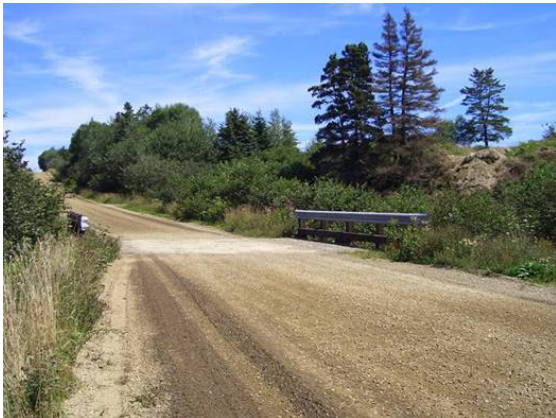
**Figure 2.** View from dirt road. Area around crossing is forested

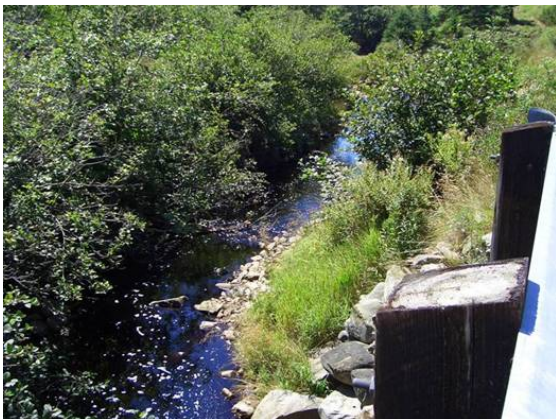
**Figure 3.** Downstream view of creek.
