Site DC47B: Salmon River

Date Assessed: 26/08/04

Road Crossing: Bridge (steel/concrete),
44m

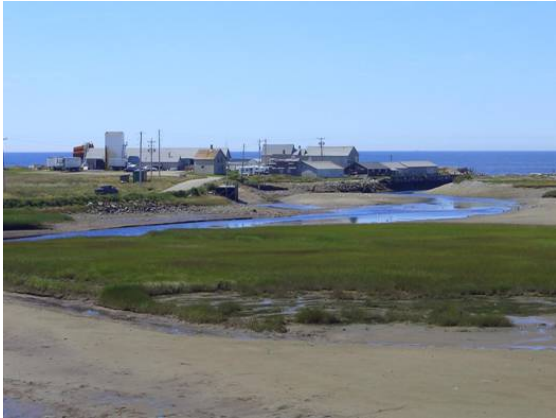
Land: Salt marsh area on the north side of river where tributary branches off, old wharf area on the south side.

Figure 1. Downstream of bridge, old wharf and buildings at mouth of river

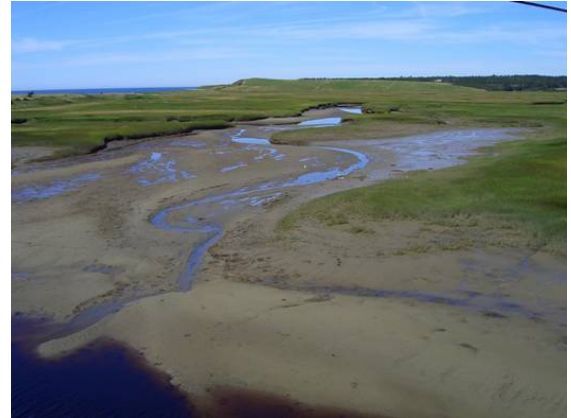
Creek: Large river (40m wide) with some bank slumping and erosion. The river branches off before it reaches the bridge, leading to DC48B.

Figure 2. Downstream of bridge, north side of river showing tributary and salt marsh system

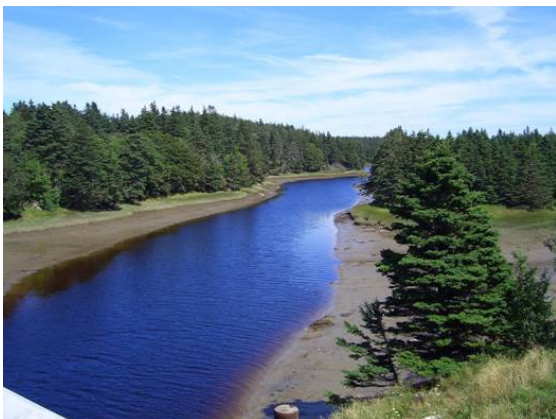
Creek: 40m wide straight flow

Land: Some marsh vegetation along edges of river, mostly wooded and residential.

Figure 3. Upstream of crossing

Comments: Remnants of an old bridge just upstream should be removed, as it may be causing some disruption to flow. This river is experiencing some erosion possibly enhanced by crossing.

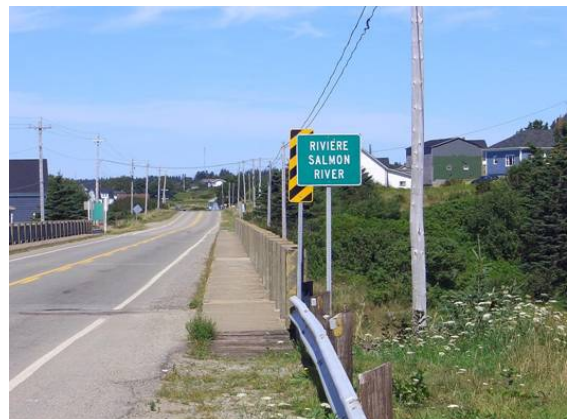
Crossing Condition: In poor condition

Figure 4. View of bridge from road.
